**HAZARDOUS MATERIALS SURVEY
FINAL REPORT**

**John F Kennedy High School
6715 Gloria Drive
Sacramento, CA 95831**

**Pool Area, Pool Equipment Room, Pool Area Restrooms
Pool Upgrade Project**

May 15, 2024

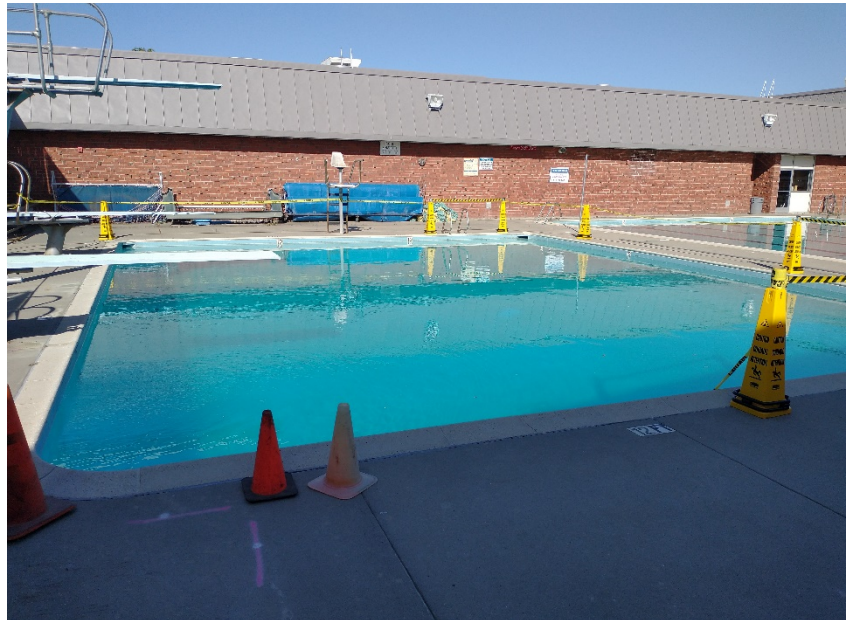
General Pool Area

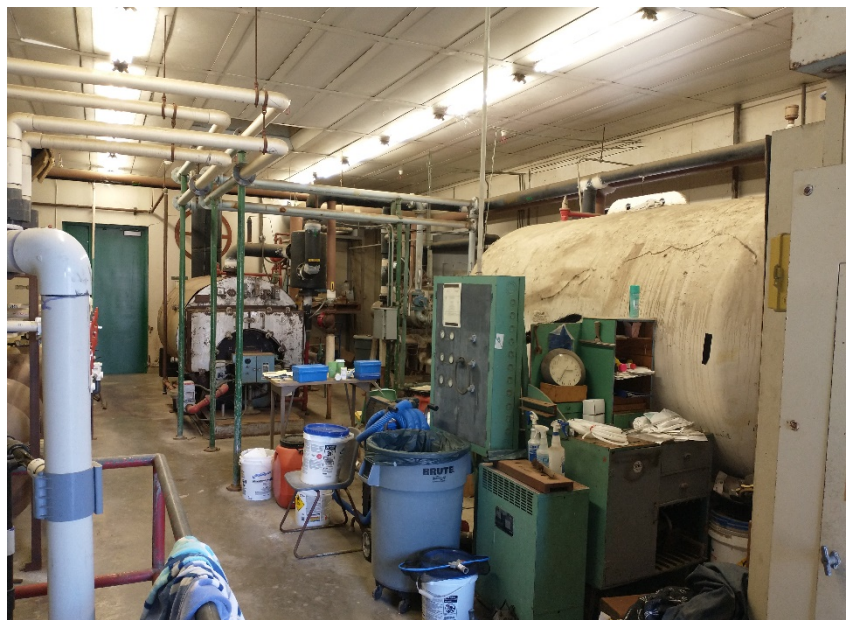
General Pool Equipment Room

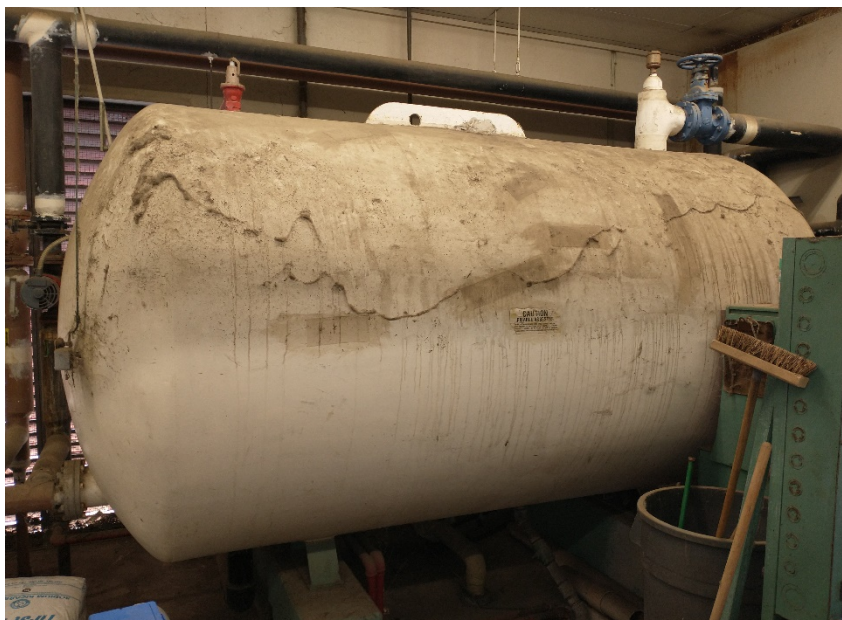
The results of testing for asbestos during this survey indicate asbestos is present in pipe insulation, tank insulation, boiler gaskets, and possible boiler materials in the pool equipment and pump room. Specifics pertaining to individual materials can be found in later sections of this report.

Large Water Tank

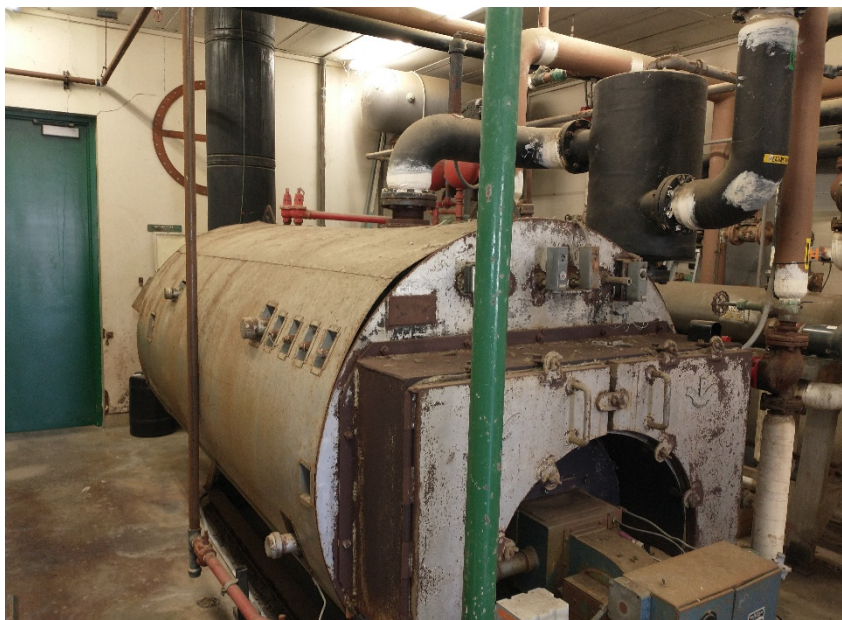
Boiler Unit

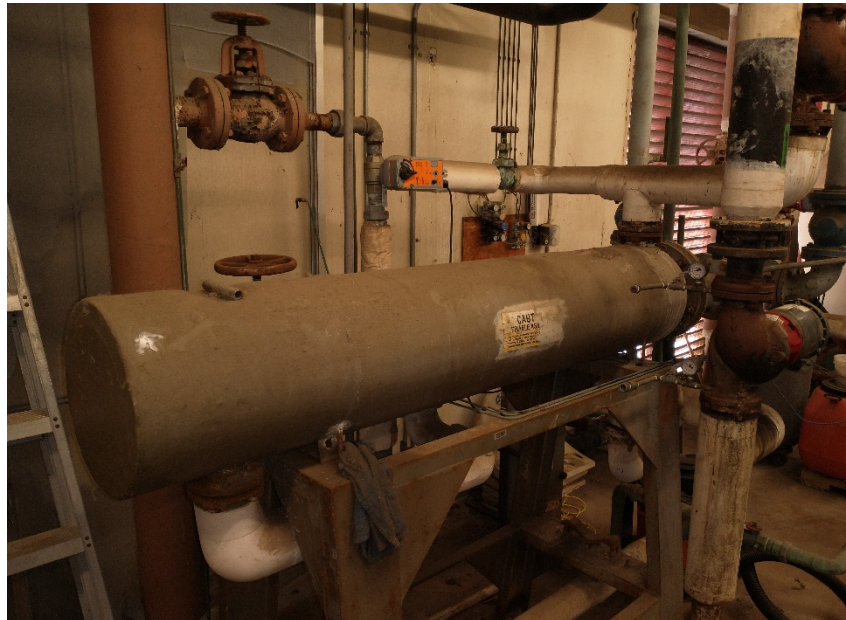
Small Tank

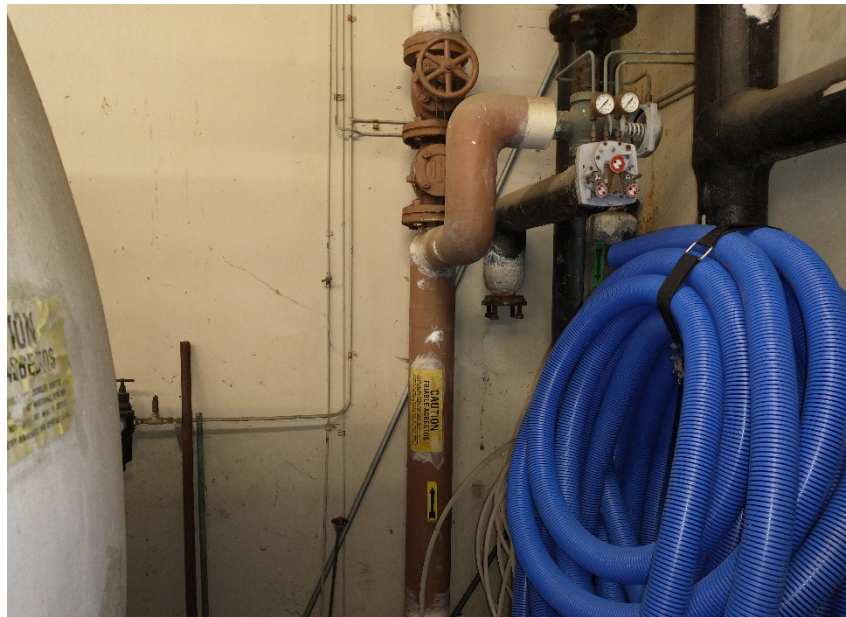
The pool equipment and pump room contains various pipe, tank, and boiler systems serving the pools. Most pipe is jacketed in asbestos containing friable insulating material. Several water tanks are present and jacketed in asbestos containing friable insulating material as well. The boiler unit has asbestos containing gasket material and may have other asbestos containing materials located in the interior. No access to the interior of the boiler was gained during this survey. The room itself has a concrete floor with a sump type pit in one corner. Drywall walls are present on the west, east, and south sides of the room. The north side of the room has walls constructed of some type of hard sound insulator board. The ceiling is a metal panel system in a large metal framed grid. Above ceiling spaces have metal roof trusses, fiberglass insulation, and fiberglass insulated pipes.

Pipe Insulation – Warning Labels Affixed
