**HAZARDOUS MATERIALS SURVEY  
FINAL REPORT**

**Luther Burbank High School  
3500 Florin Road  
Sacramento, CA 95823**

**Cafeteria Building  
Cafeteria Renovation Project**

**Entek Project #24-7336**

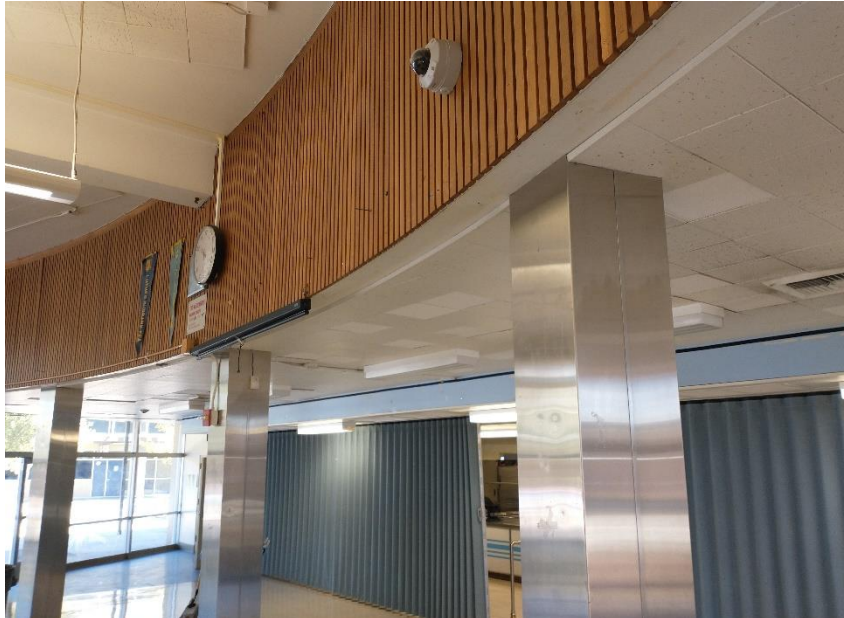
Main cafeteria – Varnished wood slat decorative wall treatment, sheet metal covered columns

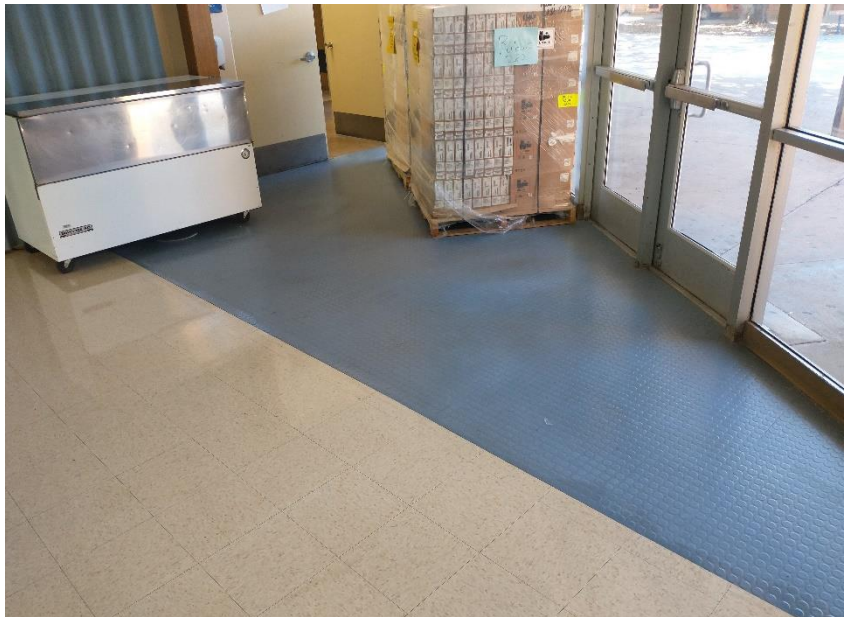
Main cafeteria – 12" vinyl floor tile, blue rubberized entry flooring

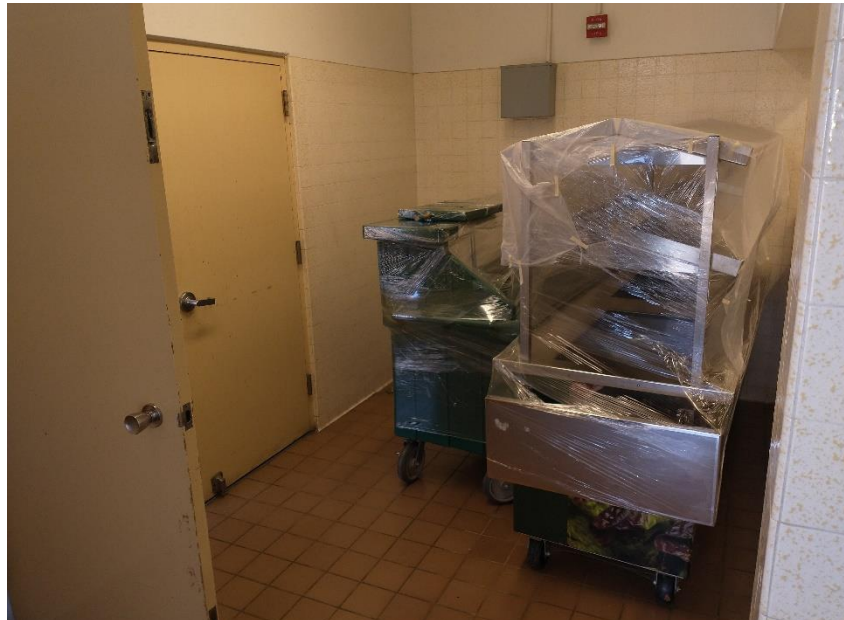
Kitchen dish was hallway passthrough area

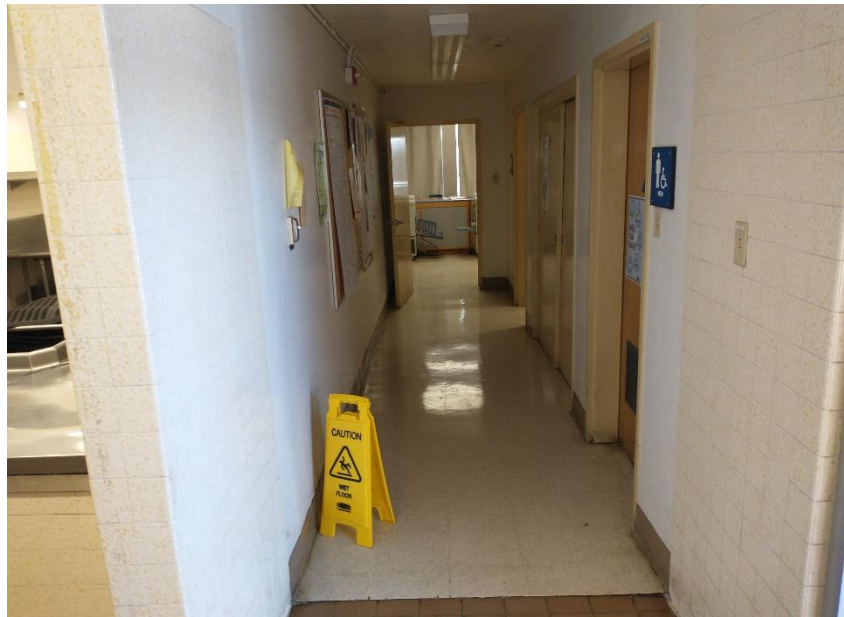
- Sublayer vinyl floor tile and black mastic found beneath the visible top layer in the teacher's lounge and hallway
- Drywall & joint compound found at walls and ceilings where present

Hallway from cafeteria through dish wash area to teacher's lounge with restrooms

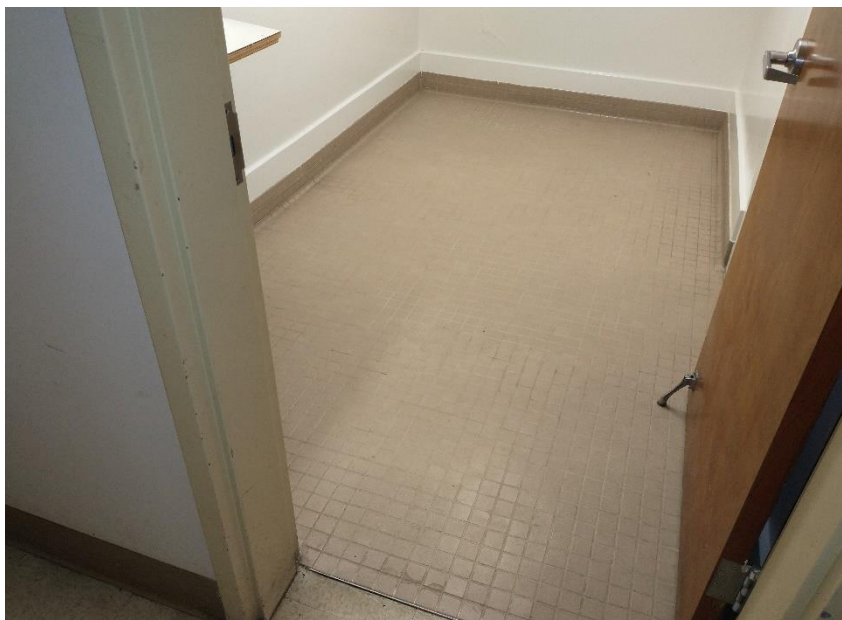
Women's staff restroom anteroom from hallway

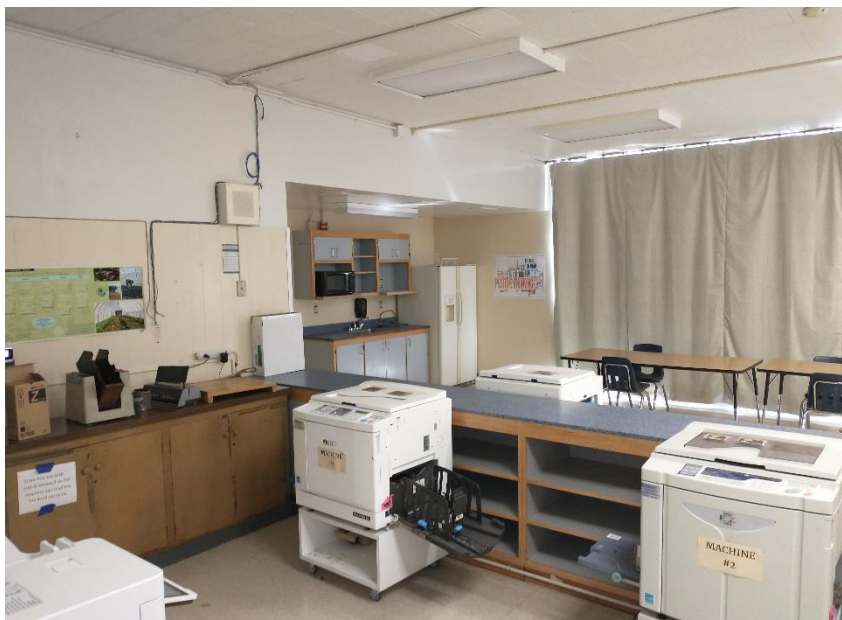
Teacher's lounge
