PETER BURNETT ELEMENTARY SCHOOL

HIGH PERFORMANCE FACILITY ASSESSMENT

NTD
ARCHITECTURE

June 2012

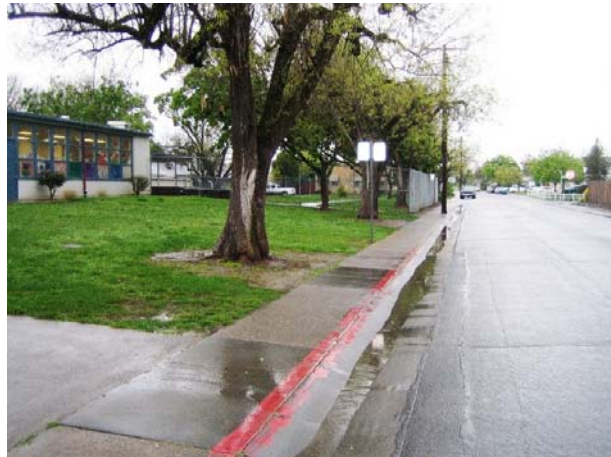
**Sustainable Sites School Entry/Drop Off**
Sidewalk along frontage is not wide enough for drop-off area. Other path of travel routs have cracks and damage.

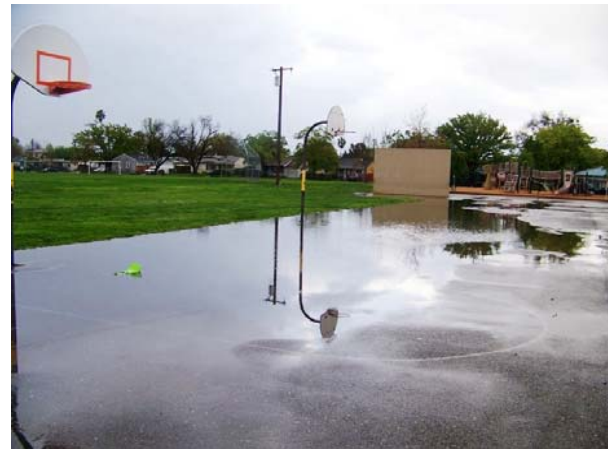
**Sustainable Sites Outdoor Activity**
Poor surface condition and drainage prevents use and creates hazardous conditions.

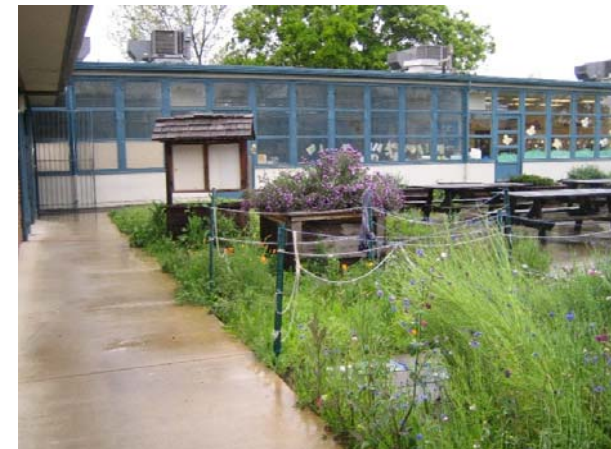
**Sustainable Sites Campus Core**
Outdoor teaching area is in disrepair and does not promote education and informal gathering opportunities.

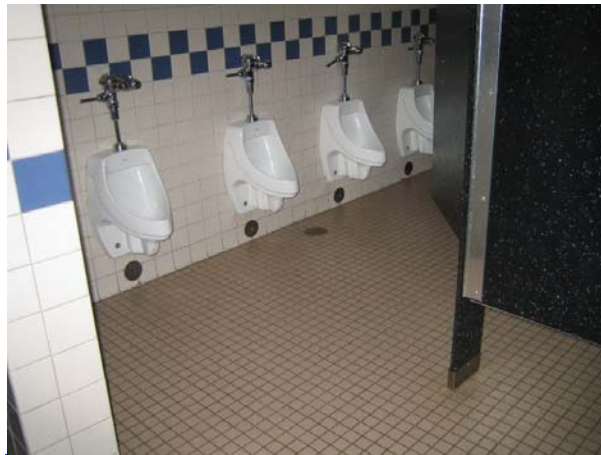
**Water Efficiency Interior**
Fixtures were replaced but more efficient flush valves could reduce water consumption.

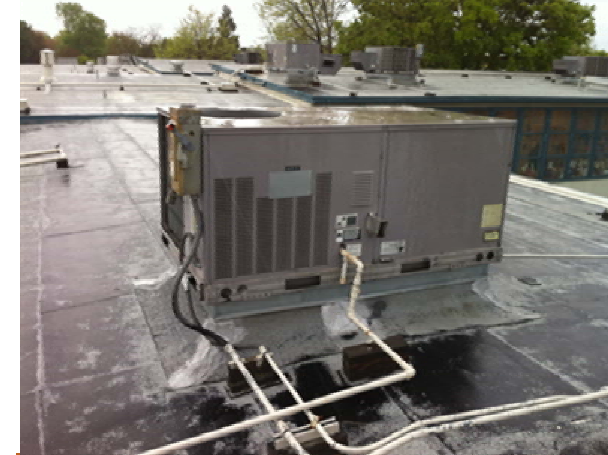
**Energy & Atmosphere**
17 year old HVAC units are at life cycle expectancy and should be replaced with more efficient systems.

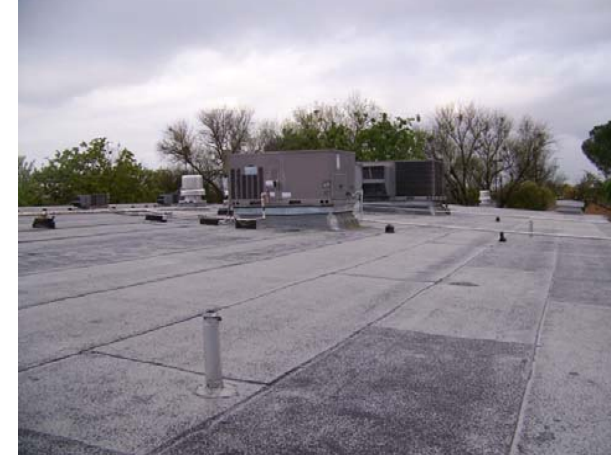
**Materials & Resources Exterior**
Mineral surface is very worn & missing in some areas. Some ponding observed and cracking observed at some seams.

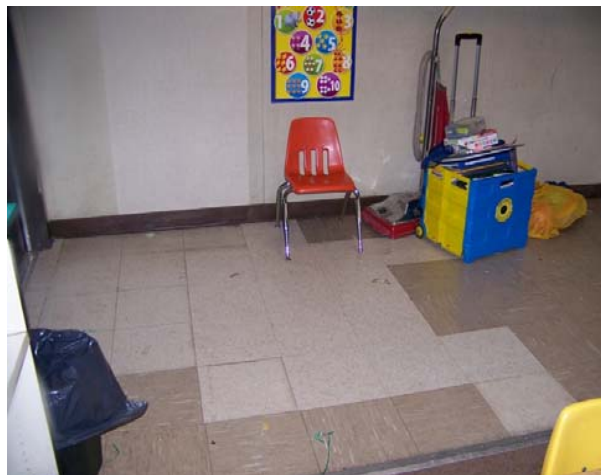
**Materials & Resources Interior**
Flooring replacement needed.

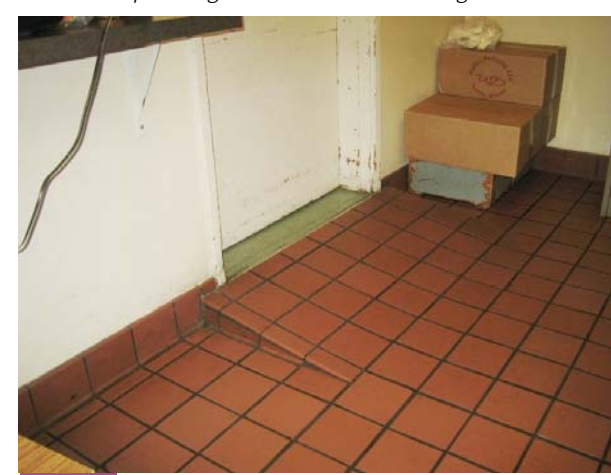
**Indoor Environmental Quality**
Window shades or draperies and more efficient, barrier free casework needed.

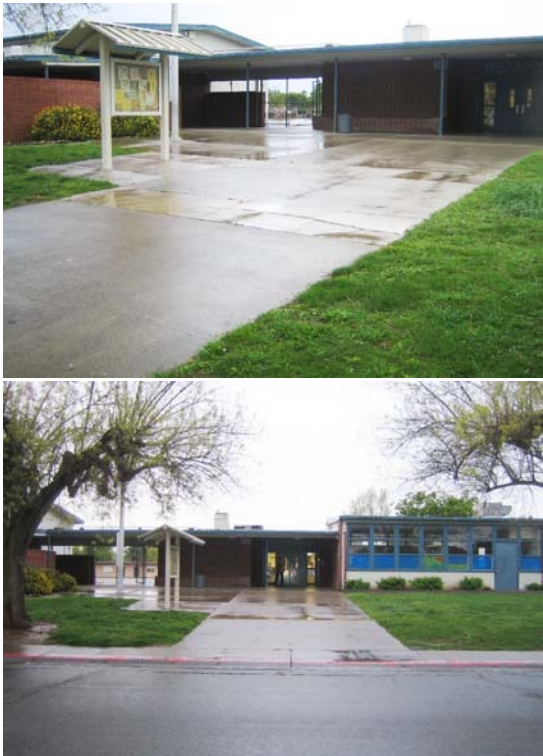
.1	P.O.T./Sidewalks	04/12	3	C	2	<p>Sidewalk along frontage is not wide enough for drop-off area. Other path of travel routes have cracks and damage.</p>

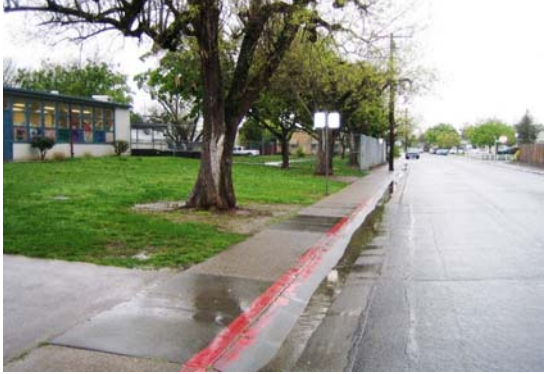
.3 Drive/Drop Off (Bus)	04/12	3	C	2	<p>Parking for drop off is in street right-of-way. Rolled curb, no designated drop off, no warnings or barrier free accessible drop-off area. Bus drop off is on 38th Avenue at rear of school, also not CBC compliant.</p>

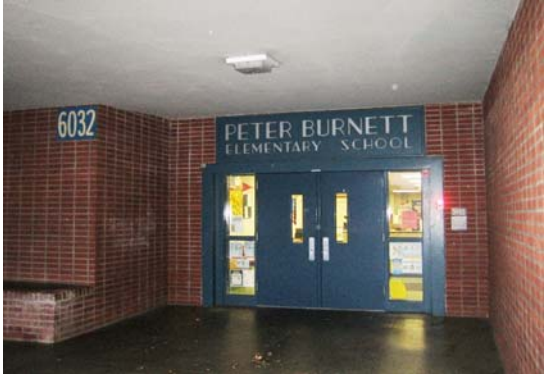
.4 Signage- Identification	04/12	2	C	2	<p>School identification on building is good but under canopy and difficult to read from street. P.O.T. and directional signage is needed.</p>

.5 Signage- Monument	04/12	3	M	1	No monument sign

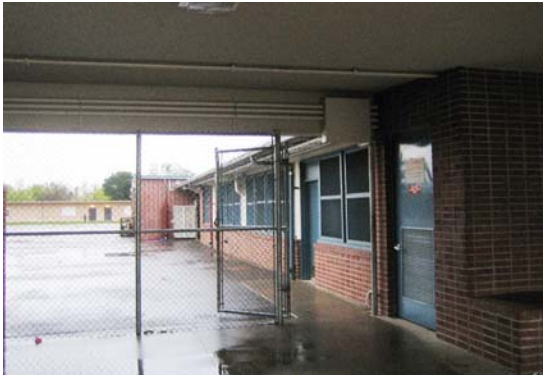
.8	Site Lighting: Type/Condition	04/12	0	-	0	NA
.9	Site Lighting: Efficiency/ Cut-off	04/12	0	HP	0	NA
.10	Building Mntd Lighting: Type/Condition	04/12	2	M	1	The building has surface mounted wall pack fixtures. The building has surface mounted canopy fixtures. Fair condition.
.11	Building Mtd Lighting: Efficiency/ Cut-off	04/12	4	HP	1	Metal halide, CFL, or HPS lamp type, not cutoff.

.12	Lighting Controls Condition	04/12	0	-	0	Fixtures are controlled with photocells or time clock.
.13	Lighting Controls Efficiency	04/12	4	HP	1	Automatic controls, needs multi level control.

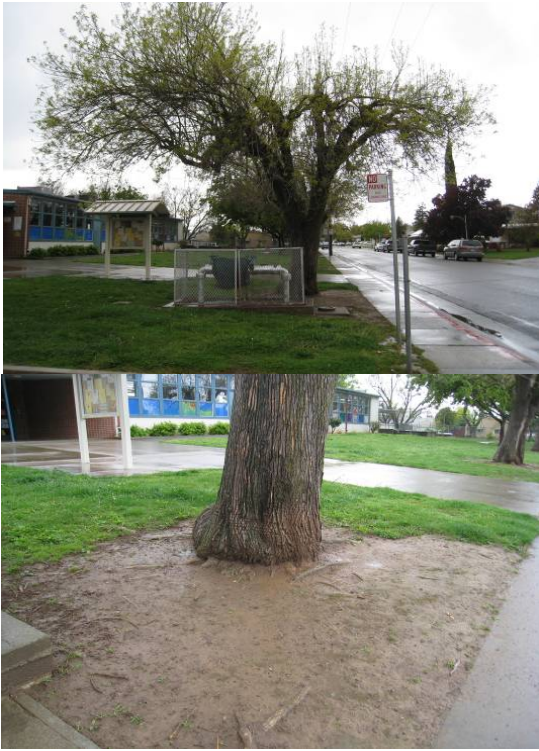
Scope	Date	Repair / Replace Level	Category	Urgency Score	<p>Repair / Replace Level: 4-New Replacement, 3-Major Repair, 2-Minor Repair, 1-Patch & Repair, 0-No observed need to replace, repair or patch</p> <p>Category: C-Code, M-Maintenance / Operations, HP-High Performance Modernization/Transformation</p> <p>Urgency Score: 3-Critical, 2-Urgent, not critical, 1-Moderate, recommended, 0-No observed need to replace repair or patch</p>
.14 Planting - Trees Condition	04/12	3	M	1	<p>Trees in front of school are in poor condition due to power line pruning and very compacted soil. Recommend planting new trees that are appropriate for planting below power lines. Recommend adding compost to soil and applying arbor mulch to soil beneath canopies.</p>

.15 Planting - Trees Adequacy	04/12	2	HP	1	Recommend planting additional trees to replace existing trees that are currently in decline.
.16 Planting-Shrub/Grndcvr Condition	04/12	3	M	1	Condition of shrubs in front of school is mixed. Some shrubs have been recently planted and are in good condition. Others are in poor condition with large gaps inbetween. The older shrubs are badly pruned. There are large amounts of turf that is unused.

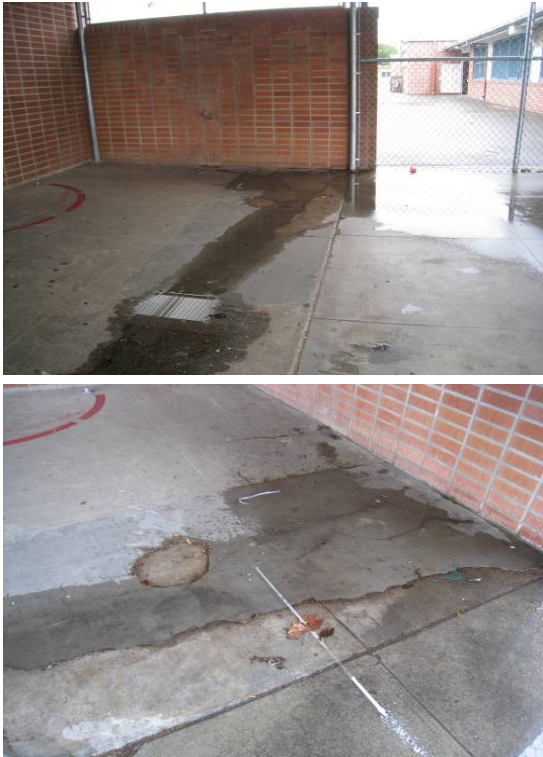
Scope	Date	Repair / Replace Level	Category	Urgency Score	<p>Repair / Replace Level: 4-New Replacement, 3-Major Repair, 2-Minor Repair, 1-Patch & Repair, 0-No observed need to replace, repair or patch</p> <p>Category: C-Code, M-Maintenance / Operations, HP-High Performance Modernization/Transformation</p> <p>Urgency Score: 3-Critical, 2-Urgent, not critical, 1-Moderate, recommended, 0-No observed need to replace repair or patch</p>
.20 Storm Water Drainage	04/12	3	M	2	<p>Water pools up under overhang near entry to cafeteria. An attempt was made to correct the drainage by adding a layer of concrete, which is now cracking and peeling off.</p>

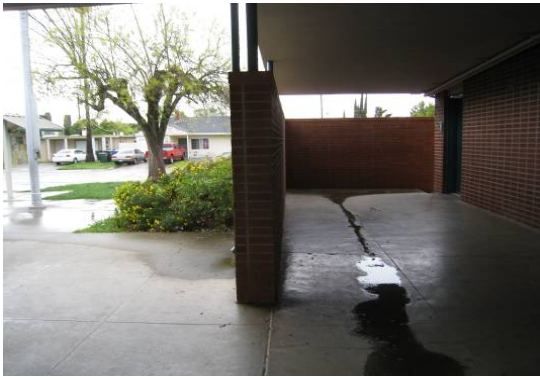
.21 Site Furnishings	04/12	4	HP	1	Recommend adding some benches at front of school
.22 Other	04/12	4	HP	2	<p>There is a brick wall at the school entry which creates an enclosure where people can hide from view. Sometimes people are found sleeping there or taking drugs, etc. This creates a very unsafe situation, and the custodian would like to have this wall reduced in height by at least half.</p>

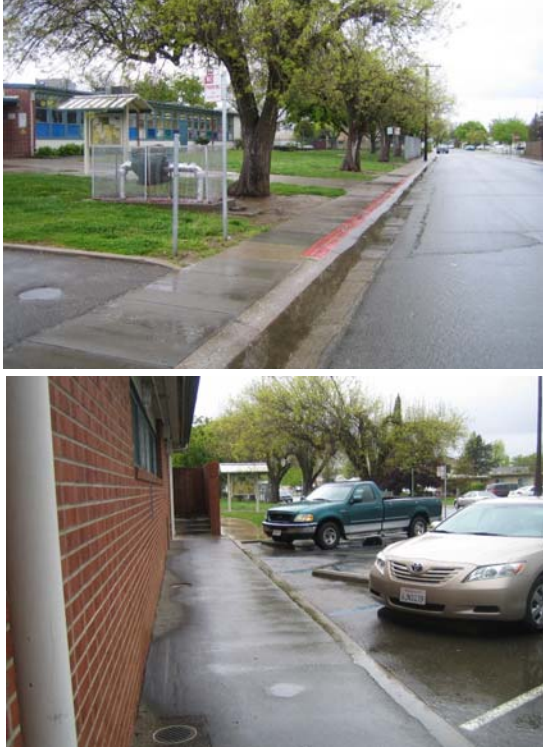
.2	Drive	04/12	3	C	1	<p>Paving appears to be in fair condition but access to and from street is across the rolled curb and sidewalk. Curb cuts with barrier free complaint ramps and clearly defined access is needed.</p>

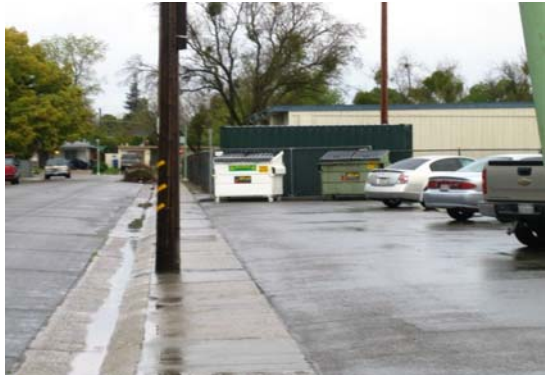
Scope	Date	Repair / Replace Level	Category	Urgency Score	
					Repair / Replace Level: 4-New Replacement, 3-Major Repair, 2-Minor Repair, 1-Patch & Repair, 0-No observed need to replace, repair or patch Category: C-Code, M-Maintenance / Operations, HP-High Performance Modernization/Transformation Urgency Score: 3-Critical, 2-Urgent, not critical, 1-Moderate, recommended, 0-No observed need to replace repair or patch
.3 Staff Parking - Condition	04/12	4	C	2	Paving appears to be in good condition and striping is faded however back up space is limited and adversely impacts the sidewalk and P.O.T. Other serious conditions noted in 2.1 & 2.2 above need to be addressed.

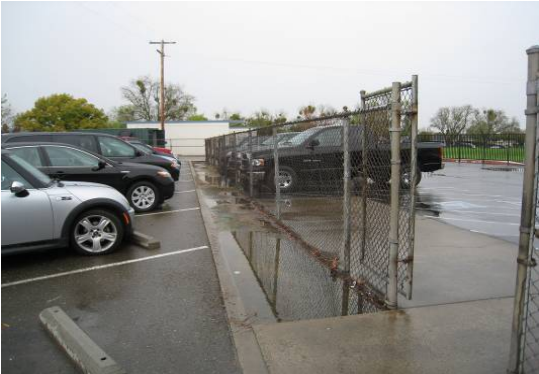
Scope		Date	Repair / Replace Level	Category	Urgency Score	
.18	Planting-Shrub/Grndcvr Condition	04/12	-	-	-	N/A
.19	Planting-Shrub/Grndcvr Adequacy	04/12	-	-	-	N/A
.20	Irrigation Condition	04/12	-	-	-	N/A
.21	Irrigation Efficiency	04/12	-	HP	-	N/A
.22	Storm Water Drainage	04/12	3	M	1	<p>Water collects in planting strip during rain. Recommend addressing this issue before planting trees to ensure that the trees have adequate drainage.</p>

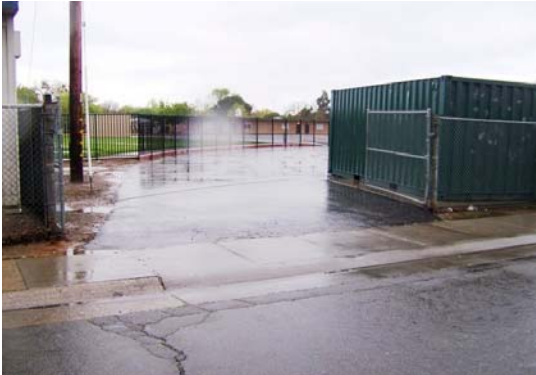
.23	Other					
3. Service Access (Fire/Maintenance/Trash Pick Up)						
.1	Drive/Vehicle Access	04/12	3	M	2	<p>Access to site and service areas is through parking and across paved play areas. Maneuvering for larger vehicles is tight.</p>

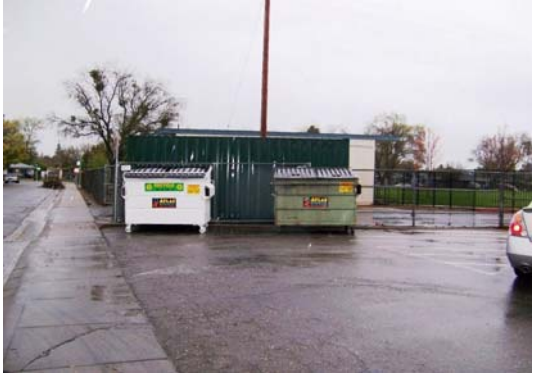
Scope	Date	Repair / Replace Level	Category	Urgency Score	
.2 Trash/Recycle Area	04/12	4	M	2	<p>Repair / Replace Level: 4-New Replacement, 3-Major Repair, 2-Minor Repair, 1-Patch & Repair, 0-No observed need to replace, repair or patch Category: C-Code, M-Maintenance / Operations, HP-High Performance Modernization/Transformation Urgency Score: 3-Critical, 2-Urgent, not critical, 1-Moderate, recommended, 0-No observed need to replace repair or patch</p> <p>Dumpsters are open and interfere with parking, and service access.</p>

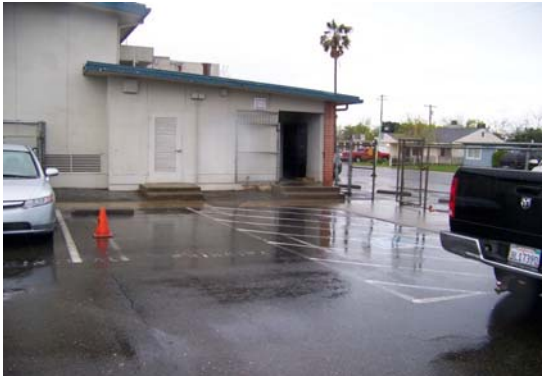
.3 Service Yard	04/12	3	M	1	<p>The service yard and access are in parking area. No ramp, steps only to building.</p>

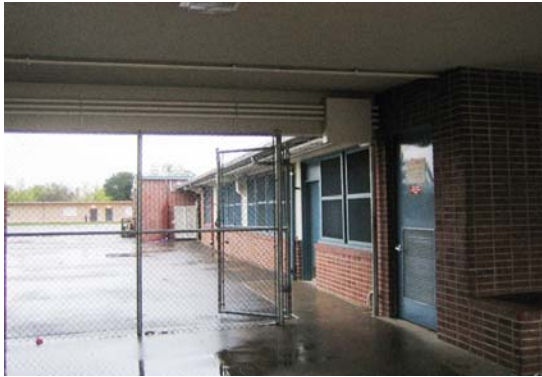
.1	P.O.T./Walks	04/12	1	C	1	<p>Appear to be in good condition, needing minor repairs.</p>

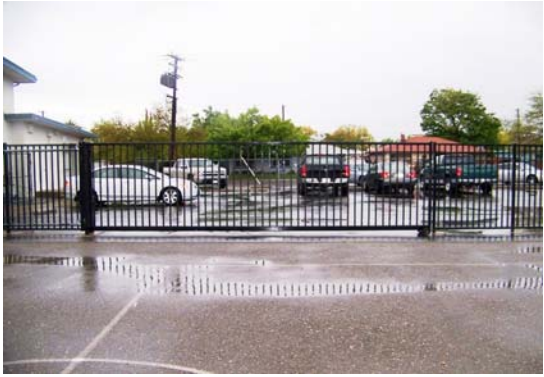
.2	Vehicle Access	04/12	1	M	1	<p>Access to core is through parking and across paved play areas. Maneuvering for larger vehicles is tight.</p>

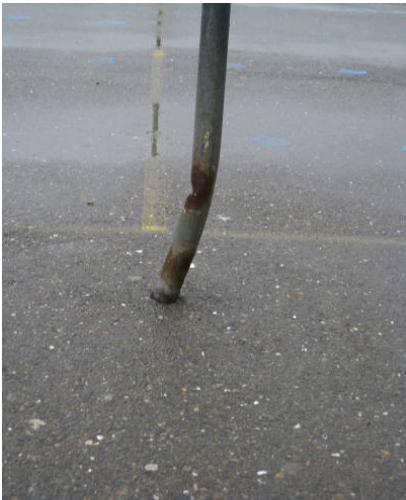
Scope	Date	Repair / Replace Level	Category	Urgency Score	Repair / Replace Level: 4-New Replacement, 3-Major Repair, 2-Minor Repair, 1-Patch & Repair, 0-No observed need to replace, repair or patch Category: C-Code, M-Maintenance / Operations, HP-High Performance Modernization/Transformation Urgency Score: 3-Critical, 2-Urgent, not critical, 1-Moderate, recommended, 0-No observed need to replace repair or patch
.10 Building Mntd Lighting: Type/Condition	04/12	-	-	-	NA
.11 Building Mtd Lighting: Efficiency/ Cut-off	04/12	-	-	-	NA
.12 Lighting Controls Condition	04/12	-	-	-	NA
.13 Lighting Controls Efficiency	04/12	-	-	-	NA
.14 Play Equipment-School-age	04/12	0	-	0	
.15 Play Equipment-Kinder	04/12	0	-	0	The play equipment is in good condition, but would benefit from shading. Recommend planting trees for shade along south side of fence at play structure. See 4.24.
.16 Sports / Fitness Equipments	04/12	2	M	1	<p>Fitness equipment is in good condition. Some Basketball hoops are in need of paint and nets. Volleyball net poles are bent and should be replaced.</p>

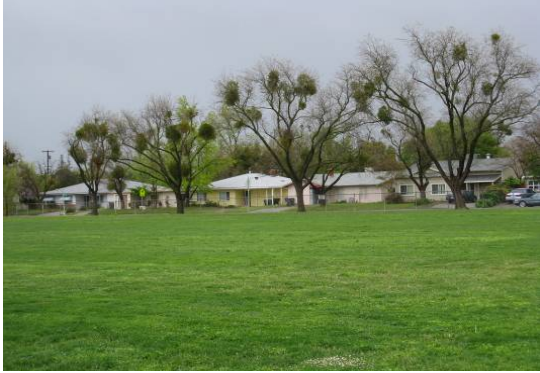
Scope	Date	Repair / Replace Level	Category	Urgency Score	<p>Repair / Replace Level: 4-New Replacement, 3-Major Repair, 2-Minor Repair, 1-Patch & Repair, 0-No observed need to replace, repair or patch</p> <p>Category: C-Code, M-Maintenance / Operations, HP-High Performance Modernization/Transformation</p> <p>Urgency Score: 3-Critical, 2-Urgent, not critical, 1-Moderate, recommended, 0-No observed need to replace repair or patch</p>
.23 Planting-Trees for Shade Condition	04/12	3	M	1	<p>Most trees are in good condition, with the exception of several mature trees around perimeter of field which are old and infested with mistletoe. Recommend planting new trees that will be replacements for the trees in decline.</p>

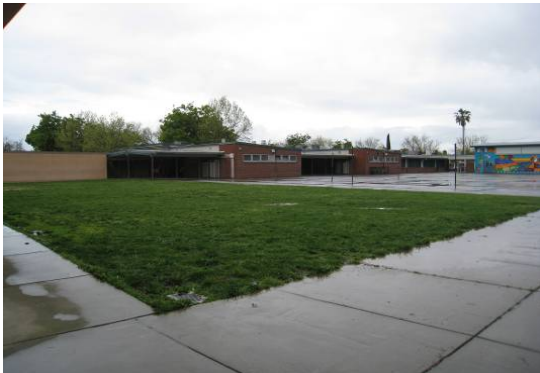
.24 Planting - Trees for Shade Adequacy	04/12	4	HP	1	<p>There is a lack of trees in the outdoor activity areas, though there are trees near the school-age play structures. Recommend planting trees to shade the kindergarten play structure. Recommend planting additional trees for shade in the grassy areas next to the asphalt yard.</p>

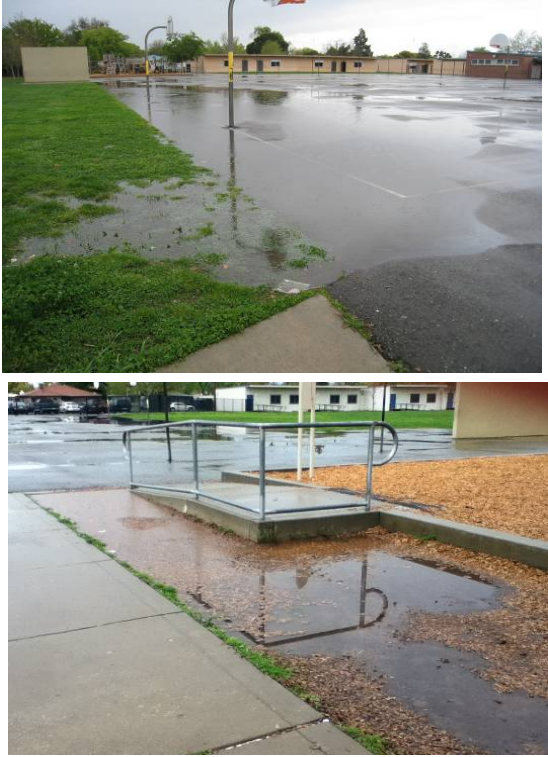
Scope	Date	Repair / Replace Level	Category	Urgency Score	<p>Repair / Replace Level: 4-New Replacement, 3-Major Repair, 2-Minor Repair, 1-Patch & Repair, 0-No observed need to replace, repair or patch</p> <p>Category: C-Code, M-Maintenance / Operations, HP-High Performance Modernization/Transformation</p> <p>Urgency Score: 3-Critical, 2-Urgent, not critical, 1-Moderate, recommended, 0-No observed need to replace repair or patch</p>
.30 Storm Water Drainage	04/12	4	HP	2	<p>A small lake forms on the blacktop area next to the sports field when it rains. Opportunity exists for rain garden in this location to address this problem. Water is also pooling up next to ramp to play structure.</p>

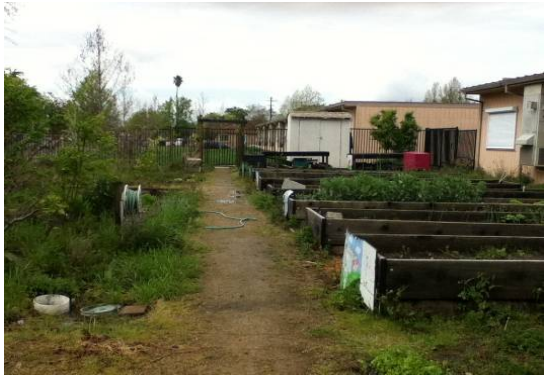
.31 Site Furnishings	04/12	0	-	0	
.32 School Garden	04/12	3	HP	2	<p>School shares a beautiful community garden on the school grounds with the surrounding community. Recommend making sure paths are wide enough for ADA accessibility requirements. Irrigation is by hose. Recommend adding backflow protection to irrigation system.</p>

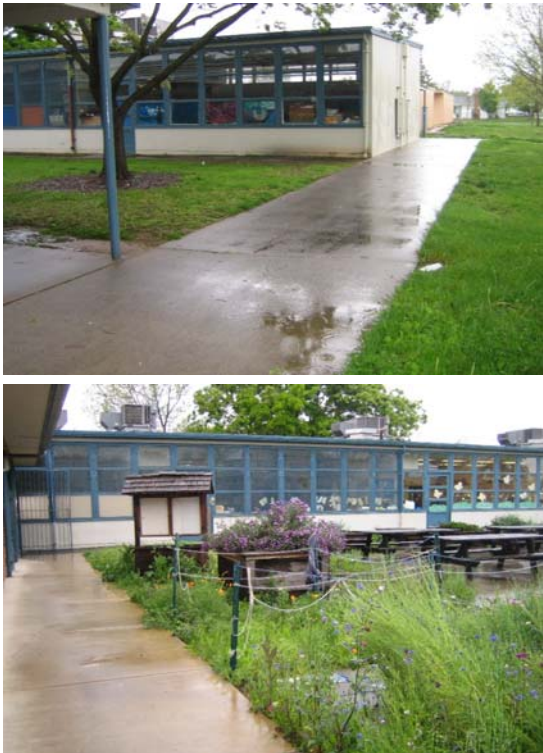
5. Campus Core						
.1	P.O.T./Walks	04/12	1	M	1	<p>Appear to be in good condition, with some areas needing minor repairs. Also see 2009 Accessibility Survey.</p>

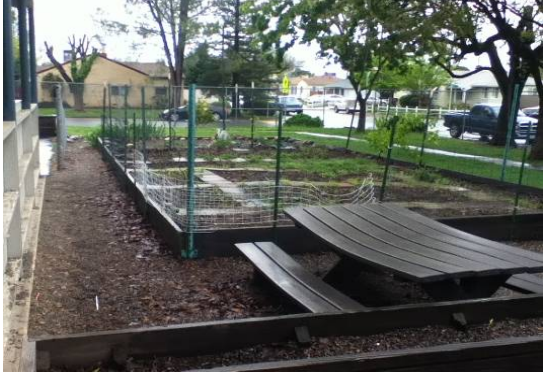
Scope		Date	Repair / Replace Level	Category	Urgency Score	
.23	Other	04/12	4	HP	1	<p>The Kindergarten area has its own garden for growing vegetables, etc. Garden is not ADA accessible. Pea gravel is used for the paths in the garden and the custodian is concerned that kids will slip when the gravel gets onto the adjacent paving. Recommend redesigning layout of garden to improve accessibility, and replacing the pea gravel with DG.</p>

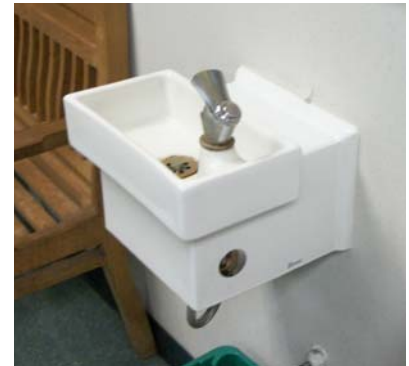
.1	Domestic Water Service: BFP	04/12	0	M	0	In good condition
.2	Domestic Water Service: Other	04/12	-	-	-	NA
.3	Fire Protection: BFP	04/12	-	-	-	NA
.4	Fire Protection: FDC	04/12	-	-	-	NA
.5	Fire Protection: PIV	04/12	-	-	-	NA
.6	Fire Protection: Other	04/12	-	-	-	NA
.7	Sanitary Sewer: Condition	04/12	-	-	-	NA
.8	Sanitary Sewer: Other	04/12	-	-	-	NA
.9	Drinking Fountain: Condition	04/12	4	M	1	Very Old
.10	Drinking Fountain: Efficiency	04/12	-	HP	-	NA
.11	Other

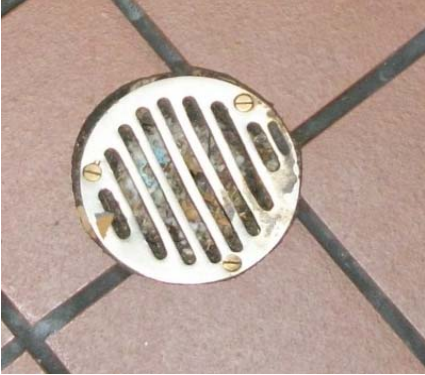
Scope		Date	Repair / Replace Level	Category	Urgency Score	<p>Repair / Replace Level: 4-New Replacement, 3-Major Repair, 2-Minor Repair, 1-Patch & Repair, 0-No observed need to replace, repair or patch</p> <p>Category: C-Code, M-Maintenance / Operations, HP-High Performance Modernization/Transformation</p> <p>Urgency Score: 3-Critical, 2-Urgent, not critical, 1-Moderate, recommended, 0-No observed need to replace repair or patch</p>
.8	Water Closets Efficiency	04/12	4	HP	1	Replace with low flow fixture
.9	Showers Condition	04/12	-	-	-	NA
.10	Showers Efficiency	04/12	-	HP	-	NA
.11	Drinking Fountain Cond	04/12	0	M	0	In fair condition
.12	Drinking Fountain Effic	04/12	-	HP	-	NA
.13	Floor Sinks	04/12	0	M	0	In fair condition
.14	Floor Drains	04/12	0	M	0	In fair condition - need cleaning

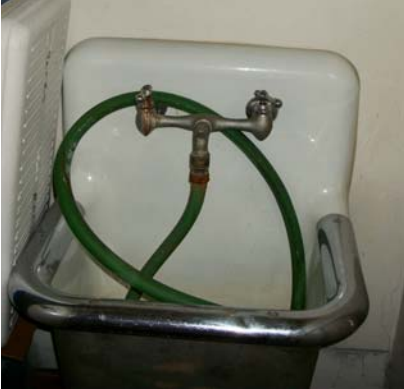
.18	Service Sinks	04/12	4	C	2	No Vacuum Breaker on faucet

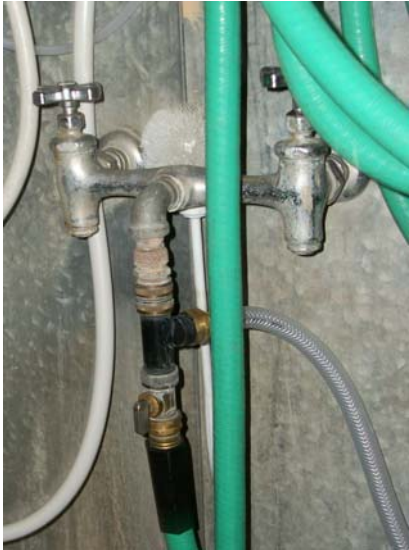
Scope		Date	Repair / Replace Level	Category	Urgency Score	Repair / Replace Level: 4-New Replacement, 3-Major Repair, 2-Minor Repair, 1-Patch & Repair, 0-No observed need to replace, repair or patch Category: C-Code, M-Maintenance / Operations, HP-High Performance Modernization/Transformation Urgency Score: 3-Critical, 2-Urgent, not critical, 1-Moderate, recommended, 0-No observed need to replace repair or patch
.19	Can Wash	04/12	4	C	2	No Vacuum Breaker on faucet

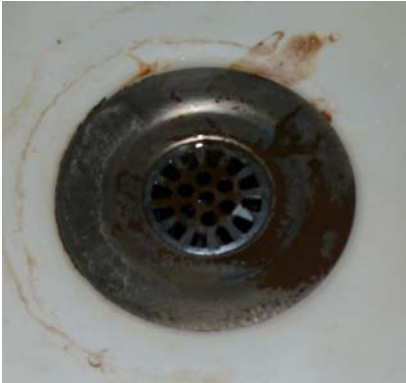
1. Plumbing Systems					
.1 Sink Condition	04/12	0	M	0	In fair condition / some rust issues

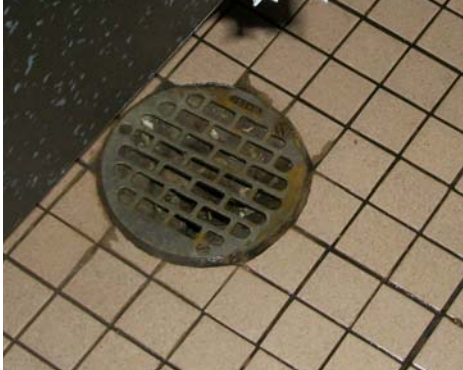
Scope	Date	Repair / Replace Level	Category	Urgency Score	
					Repair / Replace Level: 4-New Replacement, 3-Major Repair, 2-Minor Repair, 1-Patch & Repair, 0-No observed need to replace, repair or patch Category: C-Code, M-Maintenance / Operations, HP-High Performance Modernization/Transformation Urgency Score: 3-Critical, 2-Urgent, not critical, 1-Moderate, recommended, 0-No observed need to replace repair or patch
.14 Floor Drains	04/12	2	M	1	Need cleaning

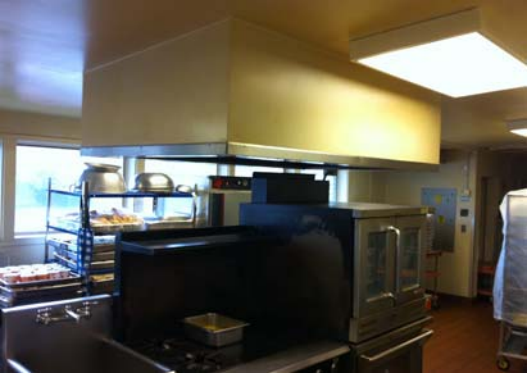
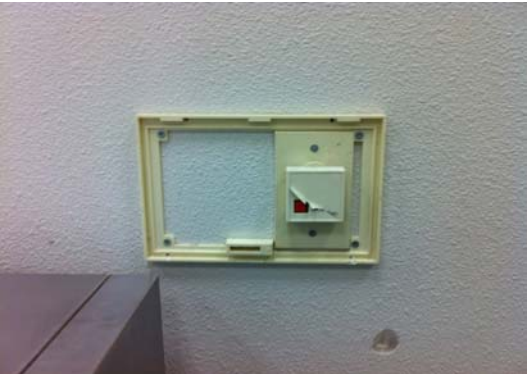
1. HVAC Systems						
.1	Equipment: Condition	04/12	4	C	1	Kitchen and MP are each served by a 2005 Bryant rooftop gas/electric AC unit, both units are in good condition. Kitchen is also served by a small Carrier split system cooling unit, in good condition. Kitchen units are on programmable thermostats, MP unit is on KMC EMS system. Kitchen hood is undersized, does not adequately cover cooking equipment, should be replaced. <div style="display: flex; justify-content: space-around; margin-top: 10px;">

</div>
.2	Equipment: Efficiency	04/12	0	HP	0	Equipment is not very old and is relatively efficient and has many years of life left, not recommended to be replaced.
.3	Ductwork	04/12	0	-	0	Ductwork appears adequate
.4	Ventilation	04/12	0	-	0	Outside air appears adequate
.5	EMS Systems: Condition	04/12	4	M	1	KMC room temp sensor in MP is broken and needs to be replaced
.6	EMS Systems: Efficiency	04/12	4	HP	1	Recommend putting the two Kitchen units on the KMC EMS control system

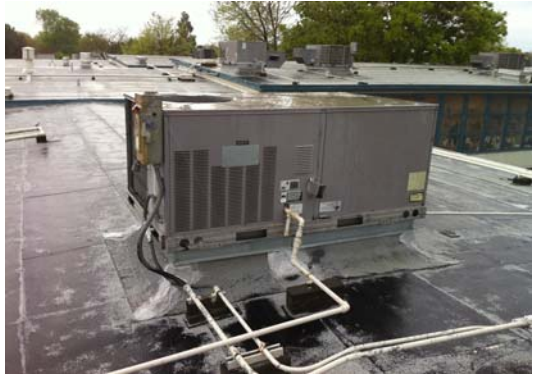
3. Alternative Energy Systems						
.1	Geo-Thermal	04/12	-	-	-	NA
.2	Solar	04/12	-	-	-	NA
.3	Other					
Building 2, Administration						
1. HVAC Systems						
.1	Equipment: Condition	04/12	4	M	1	<p>Served by two 1995 Carrier rooftop gas/elect AC units on KMC EMS control system. Units appear decent but are approaching the end of their useful life at 17 years old now and will be ready for replacement fairly soon.</p>

.2	Equipment: Efficiency	04/12	4	HP	1	17 year old units are not very efficient and don't have too many years of life left, so recommend replacing with new high efficiency units
.3	Ductwork	04/12	0	-	0	Ductwork appears adequate
.4	Ventilation	04/12	0	-	0	Outside air appears adequate
.5	EMS Systems: Condition	04/12	0	-	0	KMC EMS appears adequate
.6	EMS Systems: Efficiency	04/12	0	HP	0	Has KMC EMS, not recommended for replacement
.7	Other

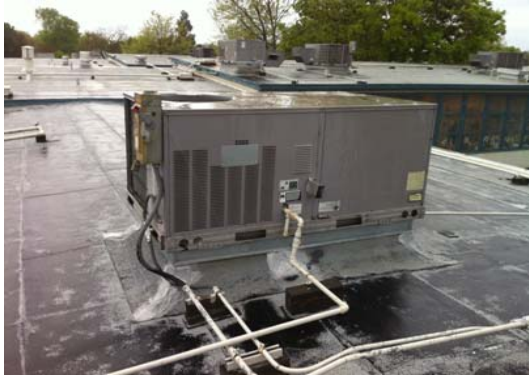
1. HVAC Systems						
.1	Equipment: Condition	04/12	4	M	1	<p>Served by two 1995 Carrier rooftop gas/elect AC units on KMC EMS control system. Units appear decent but are approaching the end of their useful life at 17 years old now and will be ready for replacement fairly soon.</p>

.2	Equipment: Efficiency	04/12	4	HP	1	17 year old units are not very efficient and don't have too many years of life left, so recommend replacing with new high efficiency units
.3	Ductwork	04/12	0	-	0	Ductwork appears adequate
.4	Ventilation	04/12	0	-	0	Outside air appears adequate
.5	EMS Systems: Condition	04/12	0	-	0	KMC EMS appears adequate
.6	EMS Systems: Efficiency	04/12	0	HP	0	Has KMC EMS, not recommended for replacement
.7	Other

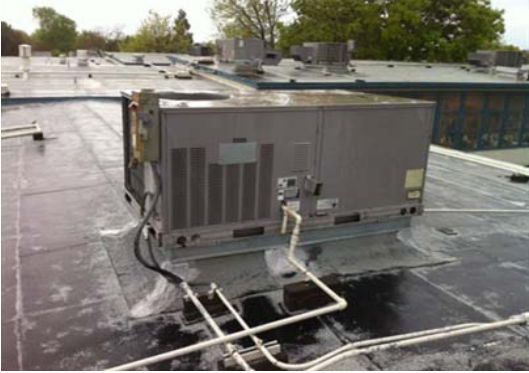
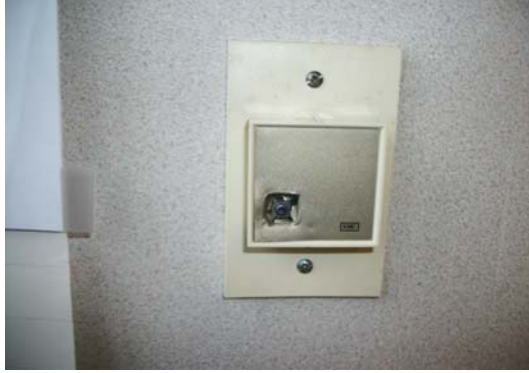
1. HVAC Systems						
.1	Equipment: Condition	04/12	4	M	1	<p>Served by 5 1995 Carrier rooftop gas/elect AC units on KMC EMS control system. Units appear decent but are approaching the end of their useful life at 17 years old now and will be ready for replacement fairly soon.</p>

.2	Equipment: Efficiency	04/12	4	HP	1	17 year old units are not very efficient and don't have too many years of life left, so recommend replacing with new high efficiency units
.3	Ductwork	04/12	0	-	0	Ductwork appears adequate
.4	Ventilation	04/12	0	-	0	Outside air appears adequate
.5	EMS Systems: Condition	04/12	4	-	1	KMC EMS appears adequate, some room sensors need replacement though
.6	EMS Systems: Efficiency	04/12	0	HP	0	Has KMC EMS, not recommended for replacement
.7	Other

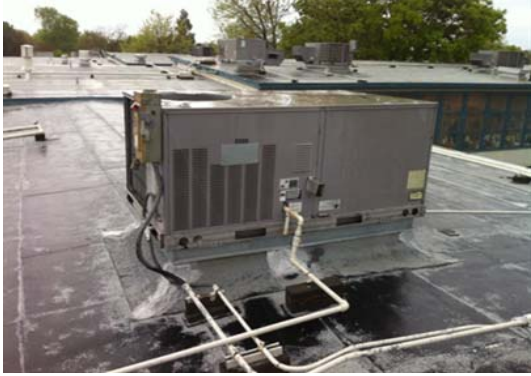
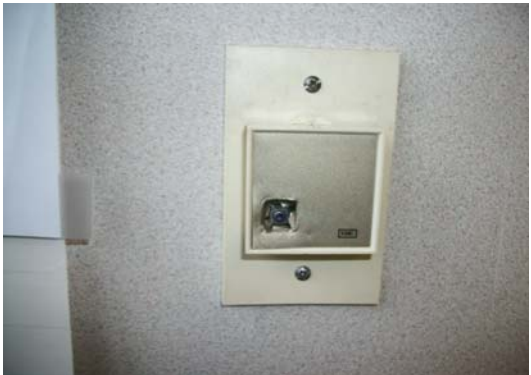
3. Alternative Energy Systems						
.1	Geo-Thermal	04/12	-	-	-	NA
.2	Solar	04/12	-	-	-	NA
.3	Other					
Building 5, Classrooms, Library & Restrooms						
1. HVAC Systems						
.1	Equipment: Condition	04/12	4	M	1	<p>Served by 5 1995 Carrier rooftop gas/elect AC units on KMC EMS control system. Units appear decent but are approaching the end of their useful life at 17 years old now and will be ready for replacement fairly soon.</p>

.2	Equipment: Efficiency	04/12	4	HP	1	17 year old units are not very efficient and don't have too many years of life left, so recommend replacing with new high efficiency units
.3	Ductwork	04/12	0	-	0	Ductwork appears adequate
.4	Ventilation	04/12	0	-	0	Outside air appears adequate
.5	EMS Systems: Condition	04/12	4	M	1	KMC EMS appears adequate, some room sensors need replacement though
.6	EMS Systems: Efficiency	04/12	0	HP	0	Has KMC EMS, not recommended for replacement

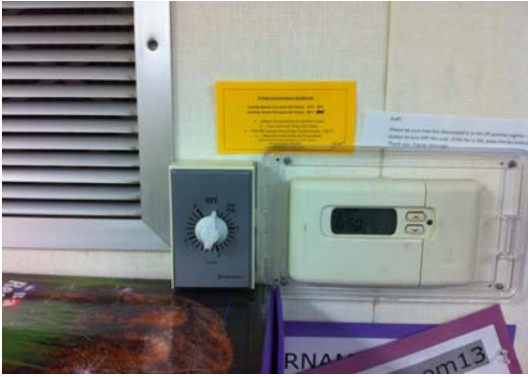
1. HVAC Systems						
.1	Equipment: Condition	04/12	0	-	0	Served by Bard gas/elect wall units, appear in good condition, with old programmable thermostats and bypass timers

.2	Equipment: Efficiency	04/12	0	HP	0	Bard units not that old, relatively efficient, replacement not recommended
.3	Ductwork	04/12	0	-	0	Ductwork appears adequate
.4	Ventilation	04/12	0	-	0	Outside air appears adequate
.5	EMS Systems: Condition	04/12	0	-	0	Old programmable thermostats, no EMS
.6	EMS Systems: Efficiency	04/12	4	HP	1	Recommend remove programmable thermostat controls and put Bards on campus KMC EMS control system
.7	Other

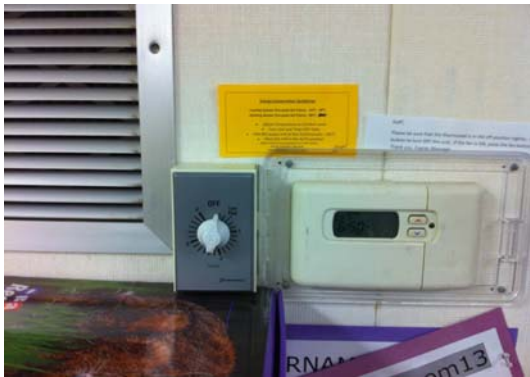
1. HVAC Systems						
.1	Equipment: Condition	04/12	0	-	0	Served by Bard gas/elect wall units, appear in good condition, with old programmable thermostats and bypass timers

.2	Equipment: Efficiency	04/12	0	HP	0	Bard units not that old, relatively efficient, replacement not recommended
.3	Ductwork	04/12	0	-	0	Ductwork appears adequate
.4	Ventilation	04/12	0	-	0	Outside air appears adequate
.5	EMS Systems: Condition	04/12	0	-	0	Old programmable thermostats, no EMS
.6	EMS Systems: Efficiency	04/12	4	HP	1	Recommend remove programmable thermostat controls and put Bards on campus KMC EMS control system
.7	Other

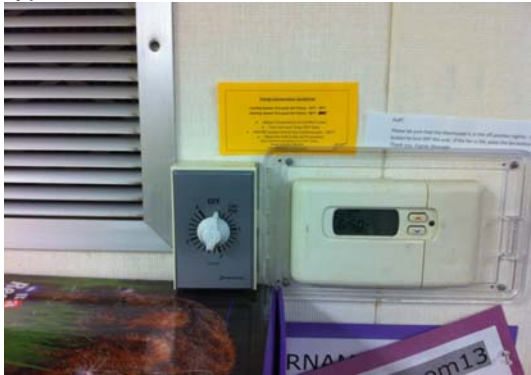
1. HVAC Systems						
.1	Equipment: Condition	04/12	0	-	0	Served by 2 Bard wall heat pumps and 2 Bard wall gas/elect units, all appear in good condition, with old programmable thermostats and bypass timers

.2	Equipment: Efficiency	04/12	0	HP	0	Bard units not that old, relatively efficient, replacement not recommended
.3	Ductwork	04/12	0	-	0	Ductwork appears adequate
.4	Ventilation	04/12	0	-	0	Outside air appears adequate
.5	EMS Systems: Condition	04/12	0	-	0	Old programmable thermostats, no EMS
.6	EMS Systems: Efficiency	04/12	4	HP	1	Recommend remove programmable thermostat controls and put Bards on campus KMC EMS control system
.7	Other

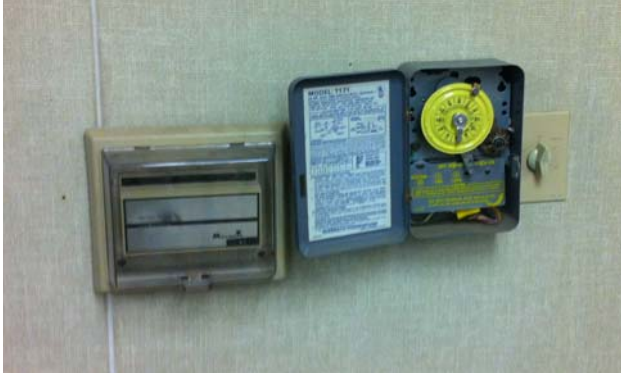
1. HVAC Systems						
.1	Equipment: Condition	04/12	4	M	1	Served by very old Bard wall heat pumps, with very old programmable thermostats and bypass timers, replacement recommended

.2	Equipment: Efficiency	04/12	4	HP	1	Old inefficient units, should be replaced with new high efficiency units
.3	Ductwork	04/12	0	-	0	Ductwork appears adequate
.4	Ventilation	04/12	0	-	0	Outside air appears adequate
.5	EMS Systems: Condition	04/12	0	-	0	Programmable thermostats, no EMS
.6	EMS Systems: Efficiency	04/12	4	HP	1	Recommend replacing old programmable thermostats with new KMC EMS controls to match rest of campus.
.7	Other

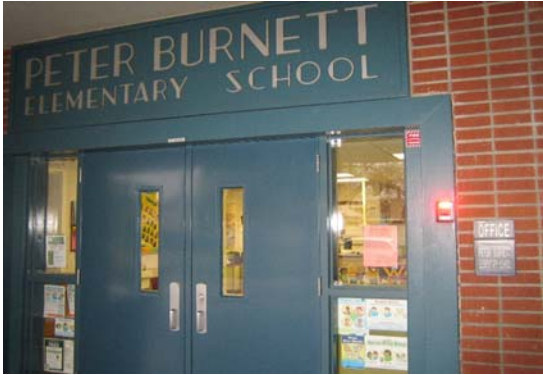
Scope	Date	Repair / Replace Level	Category	Urgency Score	<p>Repair / Replace Level: 4-New Replacement, 3-Major Repair, 2-Minor Repair, 1-Patch & Repair, 0-No observed need to replace, repair or patch</p> <p>Category: C-Code, M-Maintenance / Operations, HP-High Performance Modernization/Transformation</p> <p>Urgency Score: 3-Critical, 2-Urgent, not critical, 1-Moderate, recommended, 0-No observed need to replace repair or patch</p>
ELEMENTARY SCHOOL A. INTERIOR SPACE EVALUATION 1. Administration					
.1 Signage	04/12	3	C	2	<p>Does not comply with CBC requirements. See 2009 Accessibility Survey.</p>

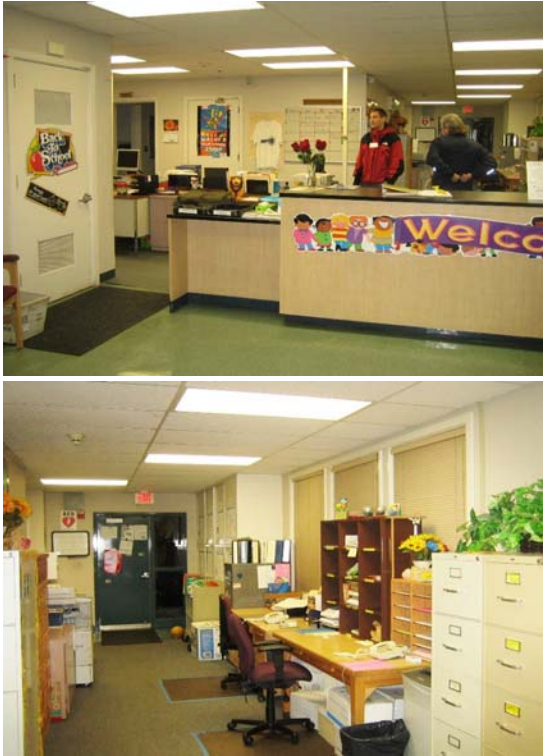
Scope	Date	Repair / Replace Level	Category	Urgency Score	<p>Repair / Replace Level: 4-New Replacement, 3-Major Repair, 2-Minor Repair, 1-Patch & Repair, 0-No observed need to replace, repair or patch</p> <p>Category: C-Code, M-Maintenance / Operations, HP-High Performance Modernization/Transformation</p> <p>Urgency Score: 3-Critical, 2-Urgent, not critical, 1-Moderate, recommended, 0-No observed need to replace repair or patch</p>
.9 Interior Finishes: Casework Condition	04/12	2	C	2	<p>Minor upgrades needed. Some clearances not compliant. Also see 2009 Accessibility Survey.</p>

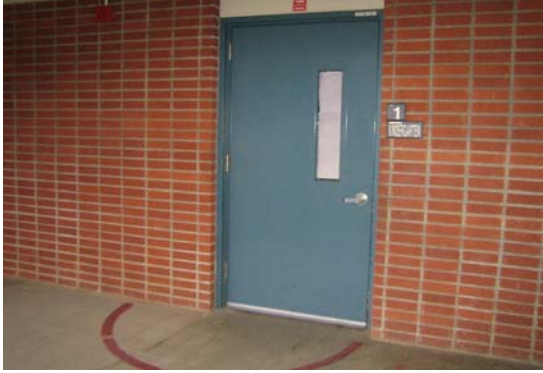
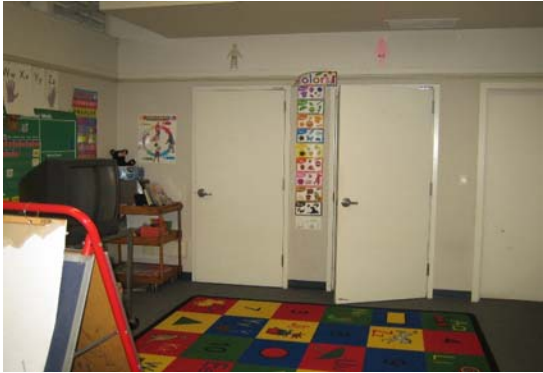
Scope		Date	Repair / Replace Level	Category	Urgency Score	
2. Kindergarten						
.1	Signage	04/12	4	C	1	Does not comply with CBC requirements. See 2009 Accessibility Survey.

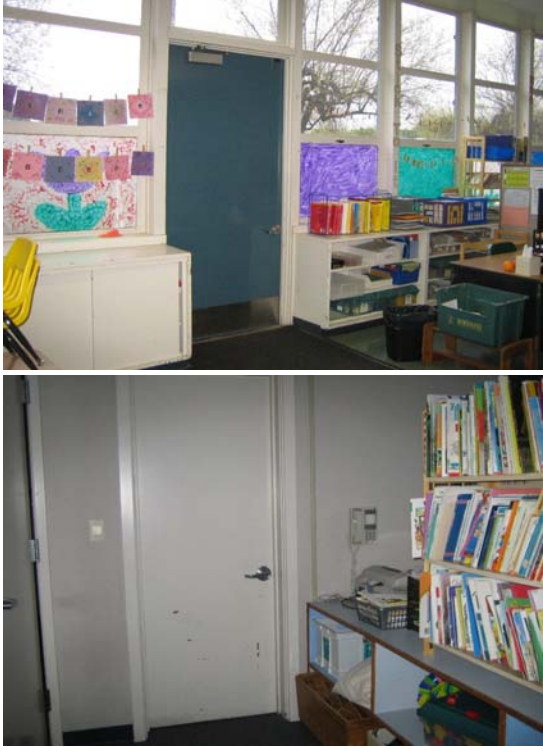
Scope		Date	Repair / Replace Level	Category	Urgency Score	
Repair / Replace Level: 4-New Replacement, 3-Major Repair, 2-Minor Repair, 1-Patch & Repair, 0-No observed need to replace, repair or patch Category: C-Code, M-Maintenance / Operations, HP-High Performance Modernization/Transformation Urgency Score: 3-Critical, 2-Urgent, not critical, 1-Moderate, recommended, 0-No observed need to replace repair or patch						
.8	Interior Finishes: Ceilings Aesthetic	04/12	1	HP	1	
.9	Interior Finishes: Casework Condition	04/12	1	M	1	
.10	Interior Finishes: Casework Aesthetic	04/12	3	C	2	<p>Some casework is compliant but some conflicts with CBC for strike side access.</p>

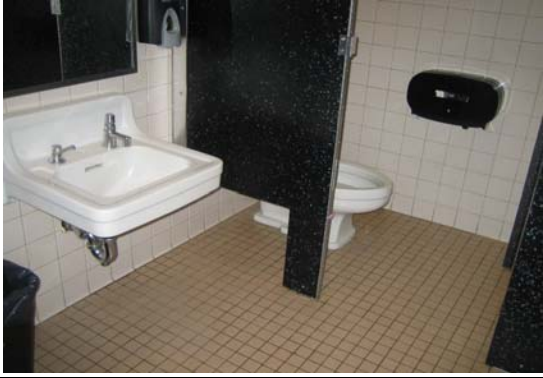
Scope		Date	Repair / Replace Level	Category	Urgency Score	
.15	Rest Rooms	04/12	3	C	2	<p>Student restrooms do not meet CBC requirements. See 2009 Accessibility Survey.</p>

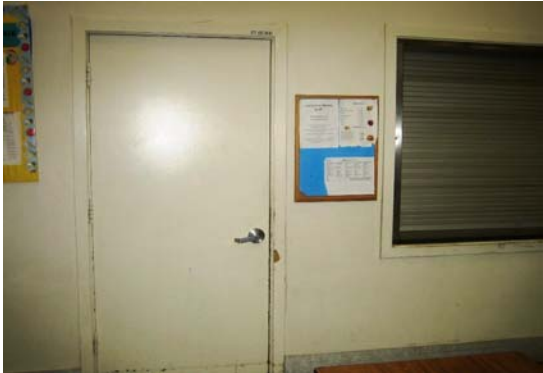
6. Kitchen						
.1	Signage	04/12	4	C	1	Does not comply with CBC requirements. See 2009 Accessibility Survey.

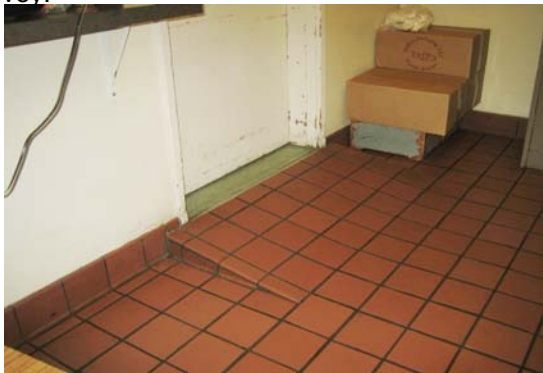
.2	Door Hardware	04/12	2	C	1	Minor revisions required. See 2009 Accessibility Survey.
.3	Interior Finishes: Floors Condition	04/12	3	C	2	Ramp at door does not comply with CBC. See 2009 Accessibility Survey.

.4	Interior Finishes: Floors Aesthetic	04/12	4	HP	1	Install seamless flooring.
.5	Interior Finishes: Walls Condition	04/12	1	M	1	
.6	Interior Finishes: Walls Aesthetic	04/12	3	HP	1	
.7	Interior Finishes: Ceilings Condition	04/12	1	M	1

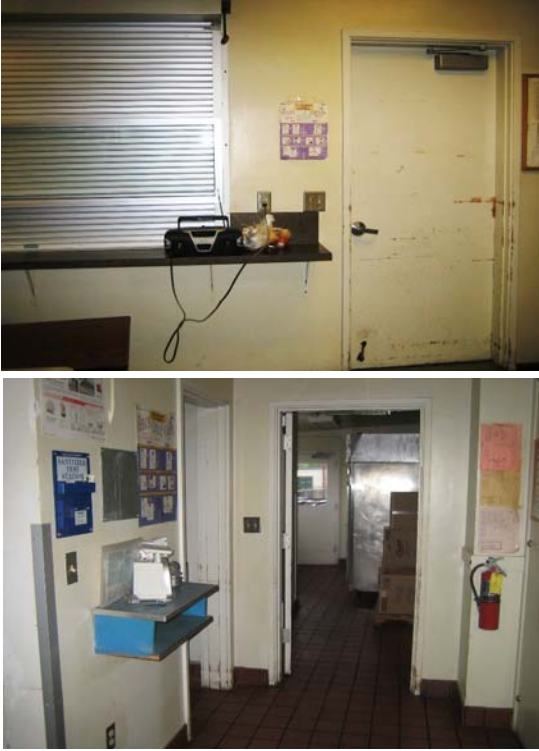
Scope	Date	Repair / Replace Level	Category	Urgency Score	<p>Repair / Replace Level: 4-New Replacement, 3-Major Repair, 2-Minor Repair, 1-Patch & Repair, 0-No observed need to replace, repair or patch</p> <p>Category: C-Code, M-Maintenance / Operations, HP-High Performance Modernization/Transformation</p> <p>Urgency Score: 3-Critical, 2-Urgent, not critical, 1-Moderate, recommended, 0-No observed need to replace repair or patch</p>
.8 Interior Finishes: Ceilings Aesthetic	04/12	4	HP	1	Install washable acoustic tiles.
.9 Interior Finishes: Casework Condition	04/12	4	C	2	<p>Casework does not comply with CBC barrier free requirements and impacts path of travel clearances. See 2009 Accessibility Survey.</p>

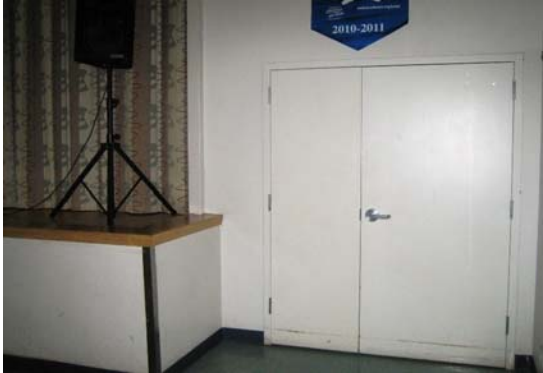
7. Stage						
.1	Signage	04/12	4	C	1	Does not comply with CBC requirements. See 2009 Accessibility Survey.

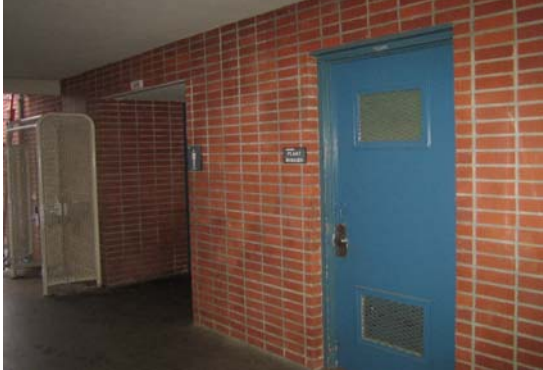
9. Restrooms- Students						
.1	Signage	04/12	4	C	1	Does not comply with CBC requirements. See 2009 Accessibility Survey.

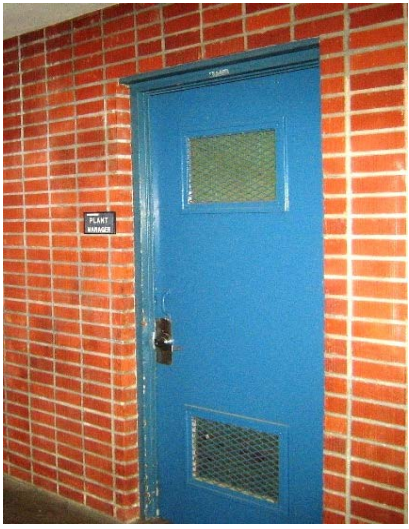
10. Utility / Support Spaces						
.1	Signage	04/12	4	C	1	Does not comply with CBC requirements. See 2009 Accessibility Survey.

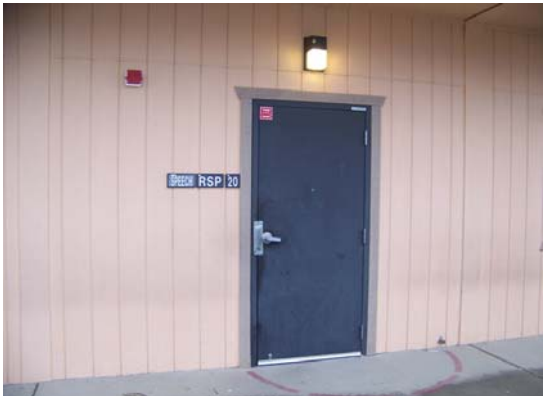
12. Portables						
.1	Signage	04/12	4	C	1	Does not comply with CBC requirements. See 2009 Accessibility Survey.

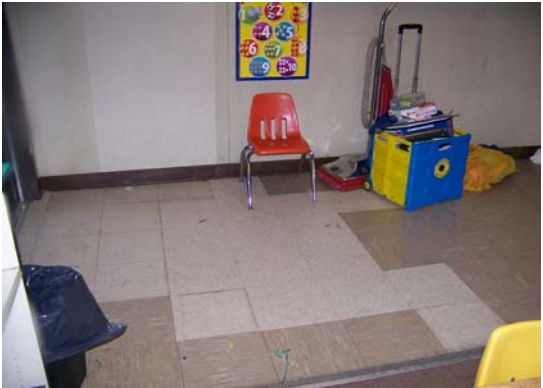
.2	Door Hardware	04/12	2	C	1	Minor revisions required. See 2009 Accessibility Survey.
.3	Interior Finishes: Floors Condition	04/12	2	M	1	
.4	Interior Finishes: Floors Aesthetic	04/12	2	HP	1	Some tile floors have been patched. Tile is not a large area and could be replaced. Clean carpets.

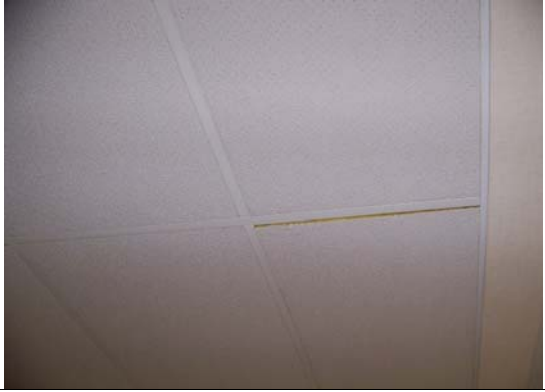
Scope		Date	Repair / Replace Level	Category	Urgency Score	Repair / Replace Level: 4-New Replacement, 3-Major Repair, 2-Minor Repair, 1-Patch & Repair, 0-No observed need to replace, repair or patch Category: C-Code, M-Maintenance / Operations, HP-High Performance Modernization/Transformation Urgency Score: 3-Critical, 2-Urgent, not critical, 1-Moderate, recommended, 0-No observed need to replace repair or patch
.6	Interior Finishes: Walls Aesthetic	04/12	1	HP	1	
.7	Interior Finishes: Ceilings Condition	04/12	1	M	1	Some ceiling panels hanging out of grid. Minor repairs.

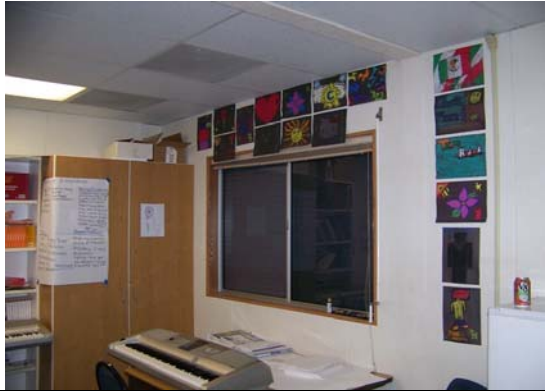
.8	Interior Finishes: Ceilings Aesthetic	04/12	1	HP	1	
.9	Interior Finishes: Casework Condition	04/12	1	M	1	
.10	Interior Finishes: Casework Aesthetic	04/12	1	HP	1	
.11	Interior Finishes: Acoustics - Condition	04/12	1	M	1	
.12	Interior Finishes Acoustics - Performance	04/12	1	HP	1	
.13	Window Shades: Condition	04/12	0	M	0	No window shades, rolling shutters at exterior of building

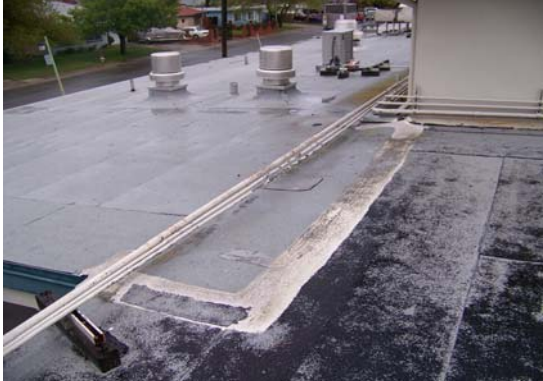
.2	Roof: Performance	04/12	2	HP	2	Roof needs attention prior to leaks developing. Recoat at a minimum, or remove and replace with new.	
.3	Skylights	04/12	-	-	-	NA
