PETER BURNETT ELEMENTARY SCHOOL

HIGH PERFORMANCE FACILITY ASSESSMENT

NTD
ARCHITECTURE

June 2012

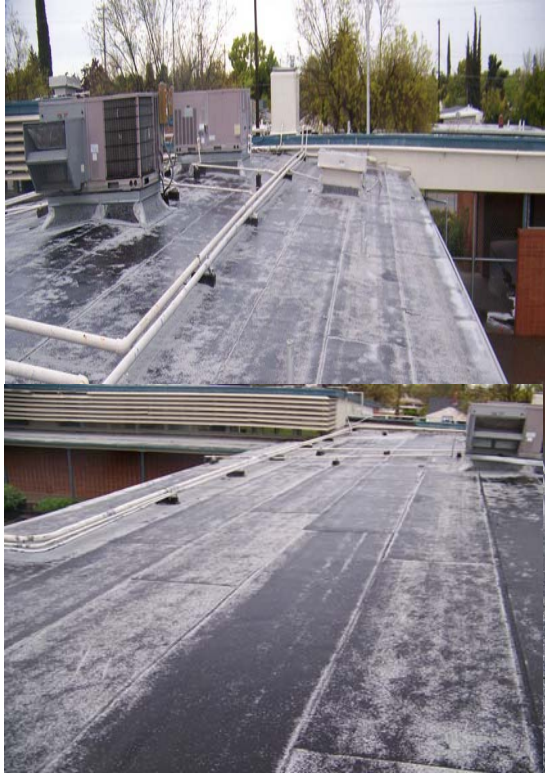
2. Building: 2, Administration

.1	Roof: Condition	04/12	4	M	2	<p>No apparent leaks, however mineral surface is very worn, completely missing in some areas, leaving the roofing material exposed. Cracking observed at some seams.</p>

.2	Roof: Performance	04/12	4	HP	2	Roof needs attention prior to leaks developing. Recoat at a minimum, or remove and replace with new.
.3	Skylights	04/12	-	-	-	NA
.4	Walls / Finishes	04/12	1	M	1	Brick and cement plaster in good condition
.5	Soffits / Overhangs	04/12	1	M	1	
.6	Gutters / Downspouts	04/12	1	M	1

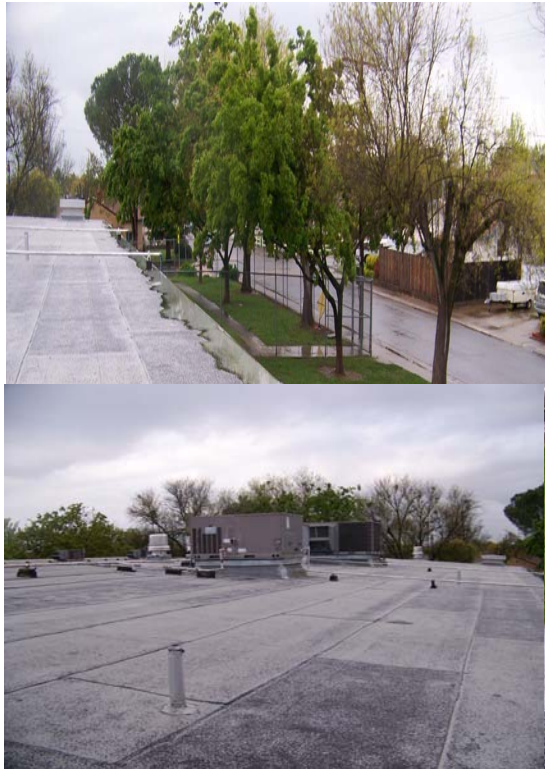
3. Building: 3, Kindergarten						
.1	Roof: Condition	04/12	4	M	2	<p>No apparent leaks, however mineral surface is very worn, completely missing in some areas, leaving the roofing material exposed. Cracking observed at some seams.</p>

.2	Roof: Performance	04/12	4	HP	2	Roof needs attention prior to leaks developing. Recoat at a minimum, or remove and replace with new.
.3	Skylights	04/12	-	-	-	NA
.4	Walls / Finishes	04/12	1	M	1	Brick and cement plaster in good condition
.5	Soffits / Overhangs	04/12	1	M	1	
.6	Gutters / Downspouts	04/12	1	M	1	
.7	Doors	04/12	1	M	1	
.8	Window Systems: Condition	04/12	1	M	1	Metal sash, single glazed
.9	Window Systems: Performance	04/12	4	HP	1	Insulated windows and glazing

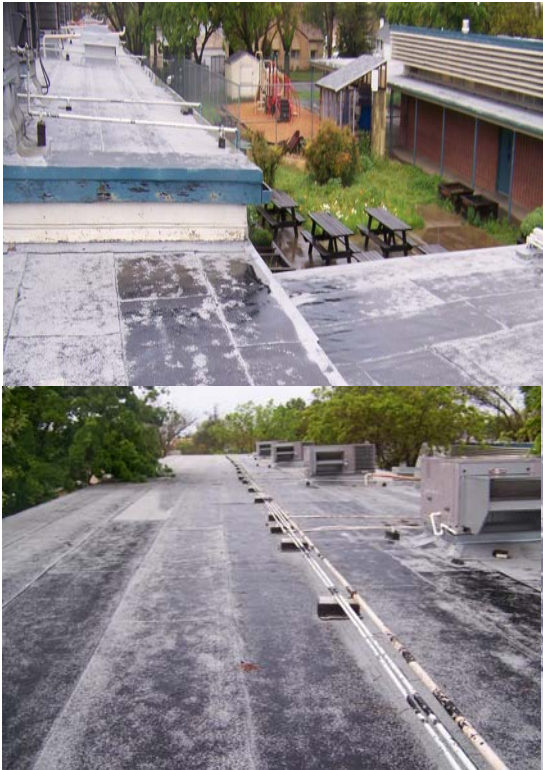
3. Buildings: 4 & 5, Classrooms, Library & Restrooms

.1	Roof: Condition	04/12	4	M	2	<p>No apparent leaks, however mineral surface is very worn, completely missing in some areas, leaving the roofing material exposed. Cracking observed at some seams.</p>

.2	Roof: Performance	04/12	4	HP	2	Roof needs attention prior to leaks developing. Recoat at a minimum, or remove and replace with new.
.3	Skylights	04/12	-	-	-	NA

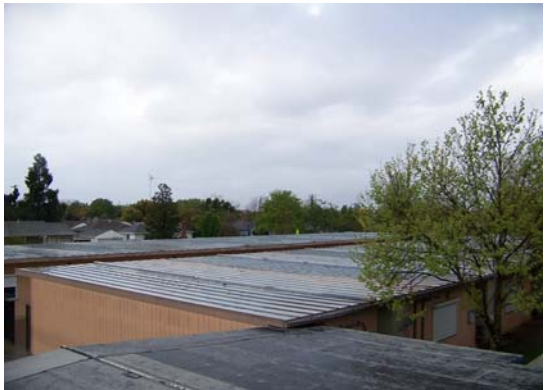
4. Portable Buildings 01 & 02, Classrooms						
.1	Roof: Condition	04/12	1	M	1	Standing seam metal roof

.2	Roof: Performance	04/12	1	HP	1	Appears to be in good condition
.3	Skylights	04/12	-	-	-	NA

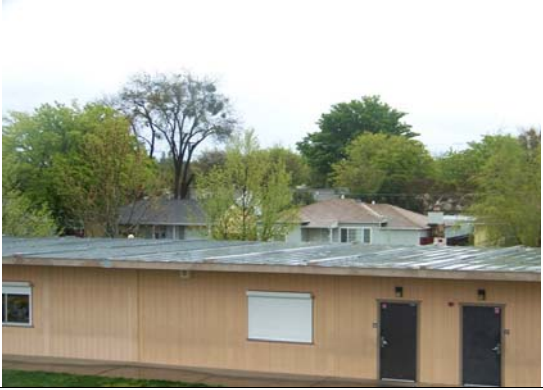
5. Portable Building 03, Classrooms

.1 Roof: Condition	04/12	1	M	1	Standing seam metal roof

.2 Roof: Performance	04/12	1	HP	1	Appears to be in good condition
.3 Skylights	04/12	-	-	-	NA
.4 Walls / Finishes	04/12	1	M	1	Materials are in good condition. Could use painting
.5 Soffits / Overhangs	04/12	1	M	1	Materials are in good condition. Could use painting
.6 Gutters / Downspouts	04/12	1	M	1	Appear to be working and unclogged

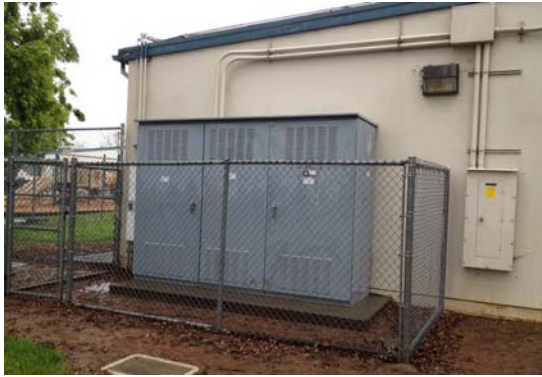
.1	Utility Service, Main Switchboard	04/12	0	-	0	<p>Electrical service originates at a exterior, 2000A, 120/208V, 3Ø, 4W mounted switchboard.</p> <p>The service size appears consistent with campuses of this size, and was recently upgraded.</p>

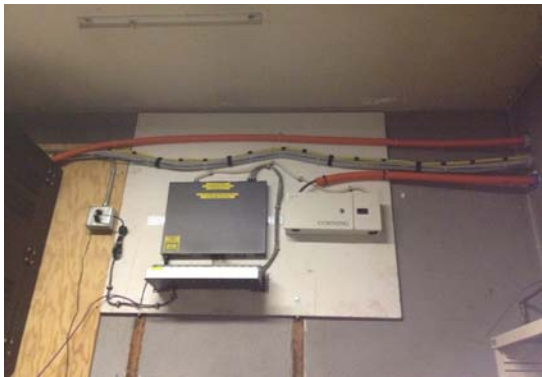
.1	Utility MPOE/MDF	04/12	0	-	0	<p>The MPOE is located in the #4 building.</p> <p>The MDF is located in the #4 building.</p> <p>The network equipment is both rack and wall mounted. The equipment was recently upgraded and is in good condition.</p>

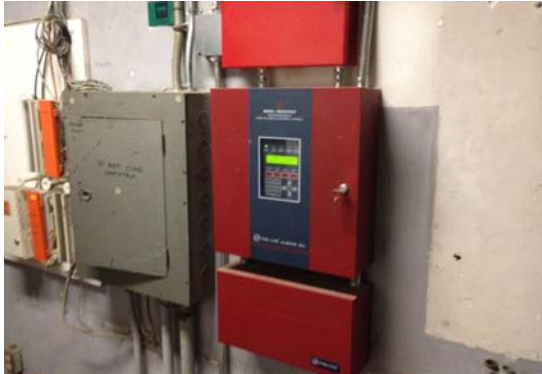
3. Low Voltage Systems						
.1	Clock/PA Head End	04/12	0	-	0	The Clock/PA system is located in the #2 building. The equipment is in good condition and recently upgraded.
.2	Fire Alarm Control Panel	04/12	0	-	0	The fire alarm control panel is a Fire Lite MS9200 system, and is located in the #2 building. The equipment is in good condition and recently upgraded.

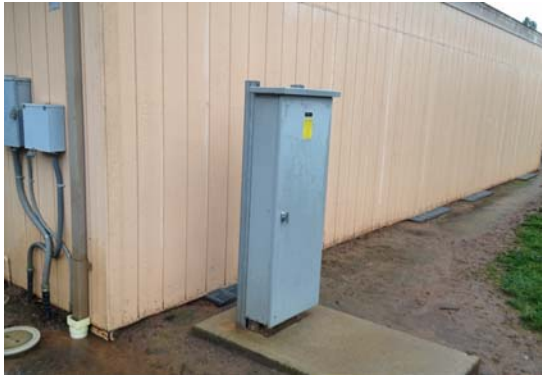
1. Electrical Systems						
.1	Electrical Rooms, Equipment Location:	04/12	0	-	0	There was no electrical room observed.
.2	Panels and Gear:	04/12	0	-	0	There were electrical panels and/or equipment surface mounted on the exterior of this building. Panels at the building were locked.

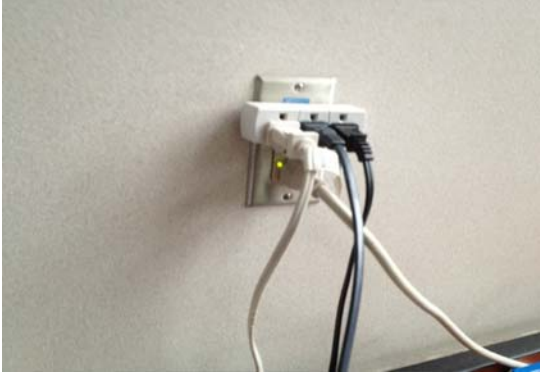
Scope	Date	Repair / Replace Level	Category	Urgency Score	<p>Repair / Replace Level: 4-New Replacement, 3-Major Repair, 2-Minor Repair, 1-Patch & Repair, 0-No observed need to replace, repair or patch</p> <p>Category: C-Code, M-Maintenance / Operations, HP-High Performance Modernization/Transformation</p> <p>Urgency Score: 3-Critical, 2-Urgent, not critical, 1-Moderate, recommended, 0-No observed need to replace repair or patch</p>
.3 Receptacles / Branch Circuiting	04/12	2	M	1	<p>No receptacles at the building were labeled. Surface raceways are used for power devices. There are insufficient quantity of receptacles at this building.</p>

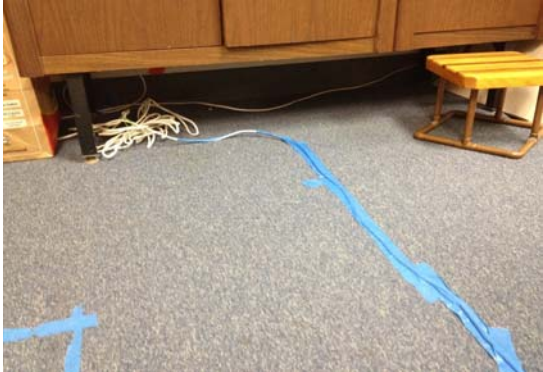
3. Technology Systems						
.1	IDF	04/12	0	-	0	No IDF rack was observed.
.2	Infrastructure (Raceway, Cabling)	04/12	2	M	1	Low voltage cabling installed in surface raceway. Low voltage cabling surface mounted or exposed.
